Richmond Street and Sidewalk Audit

Prepared by the Richmond Transportation Committee

4/28/2023

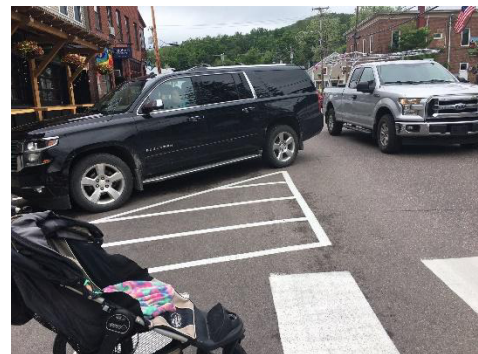
Bridge Street Commercial Corridor

In this section, volunteers observed a range of issues that inhibit pedestrian mobility. Sections of sidewalks along Bridge Street are either too steep or too narrow for wheelchairs and strollers. The curb cuts at the crosswalk on Bridge Street in front of the Town Library are not flush with the road. The sidewalk and roadway in front of the Masonic Block (as shown in right Figure) and between Railroad Street and Volunteers Green have many obstructions- including signage, planters, tables, chairs and bicycles in the sidewalks, and utility poles in the Bridge Street roadway and/or sidewalks. Sidewalk and curbing on Bridge Street are degraded. The midblock placement of the rectangular rapid flashing beacon (RRFB) at the Masonic Block is not adequately visible to drivers. Signage is inadequate on Bridge Street in front of the Town Center and at the Railroad Street intersection.

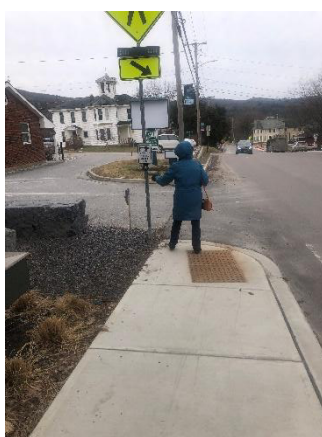
Pedestrian Crossing

There is no sidewalk on the east side of Bridge Street south of the Big Spruce restaurant. The Town Offices, the police station, the post office, and the public library are all located on the east side of the street. People who live or work on the east side of Bridge Street have to cross the street twice to gain access to these public services. For children and residents who are mobility impaired, this presents a challenge.

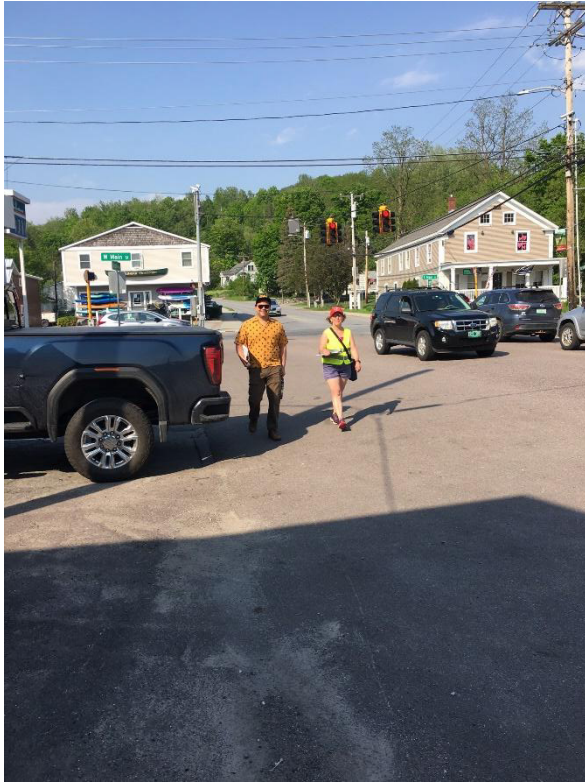
Parked cars force pedestrians into street

The gap in the sidewalk along Bridge Street in front of the Cumberland Farms gas station, as shown in the above figures creates a dangerous situation for pedestrians. This section is a large curb cut in which cars enter and exit the gas station, and park between the convenience store and Bridge Street. This segment has no pedestrian facilities and no clear guidance for pedestrians on how to cross the curb cut. Bollards and trash cans keep parked vehicles about two feet from the exterior building wall of the Cumberland Farms building, leaving a distance of about 20 feet to the edge of the roadway. Parked Vehicles force pedestrians out into the roadway.

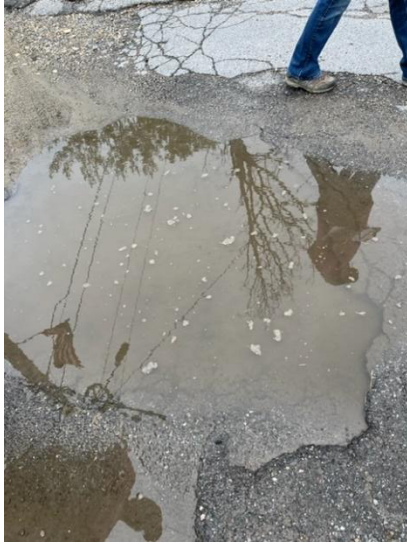
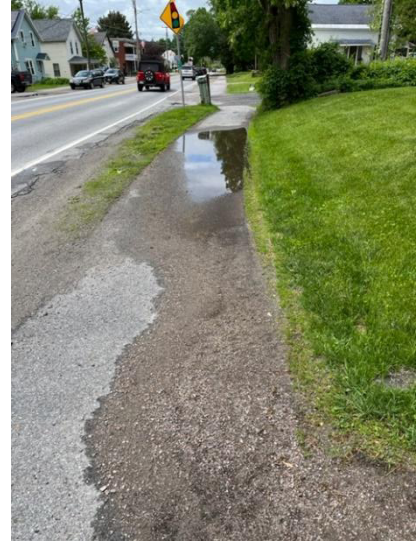
Drainage Issues on East Main St. leads to puddling on sidewalks

The sidewalks are deteriorating (as shown in the above figure), thus rendering them inaccessible to some users. Speeding issues and drainage issues are also evident and there is a lack of demarcation between the roadway and the sidewalk. At certain points, the sidewalk looks like a shoulder and is used by cars to park (as shown in the below figure), thereby obstructing pedestrians.

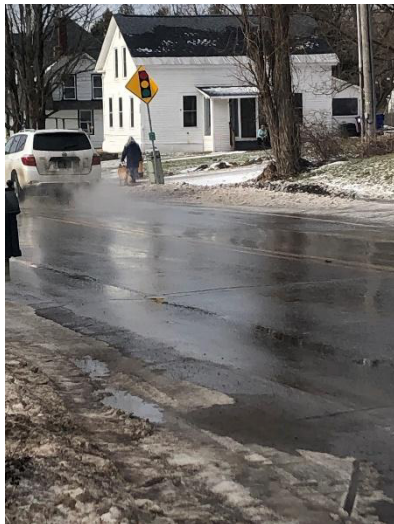
Sidewalk shoulders used for car parking

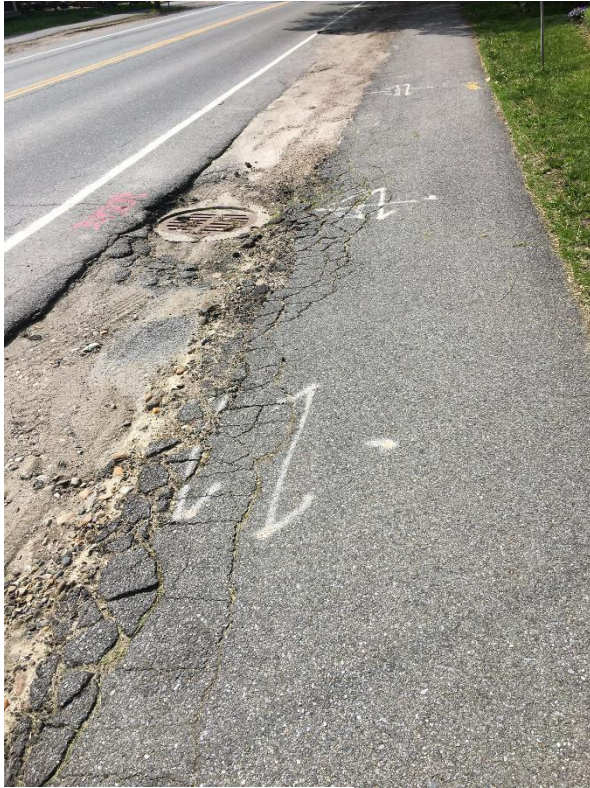
Deteriorated sidewalk

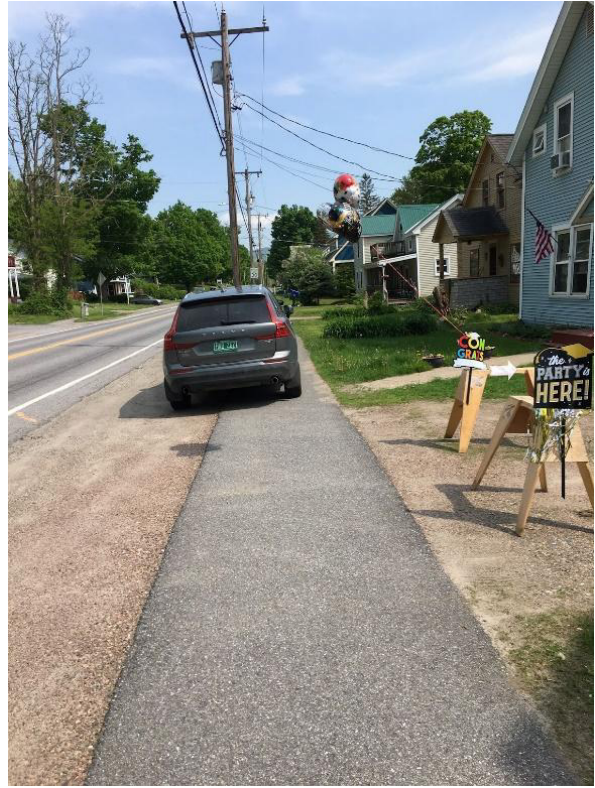
Car park on the sidewalk

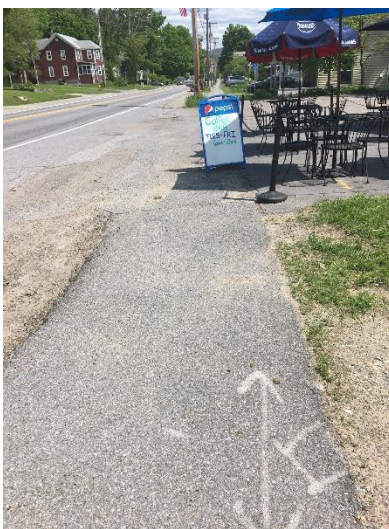
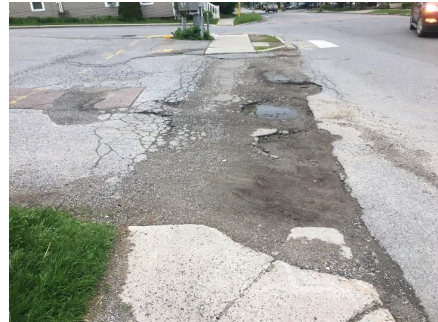
Deteriorated sidewalks and curbs

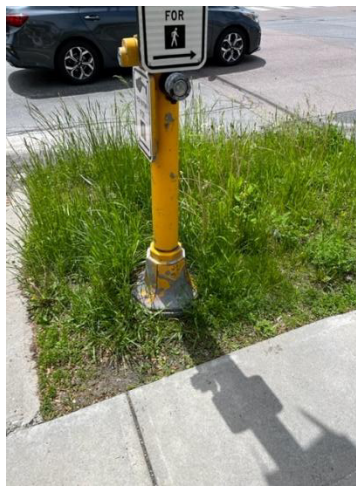
Walk signal for pedestrians

Volunteers observed that the walk signal gives pedestrians a five-second advance before the green light signal for traffic going straight. However, the intersection lacks a “no right turn” signal for vehicles when the walk sign is activated. Volunteers also noted the lack of a clear sight line from Bridge Street northbound to East Main Street eastbound.

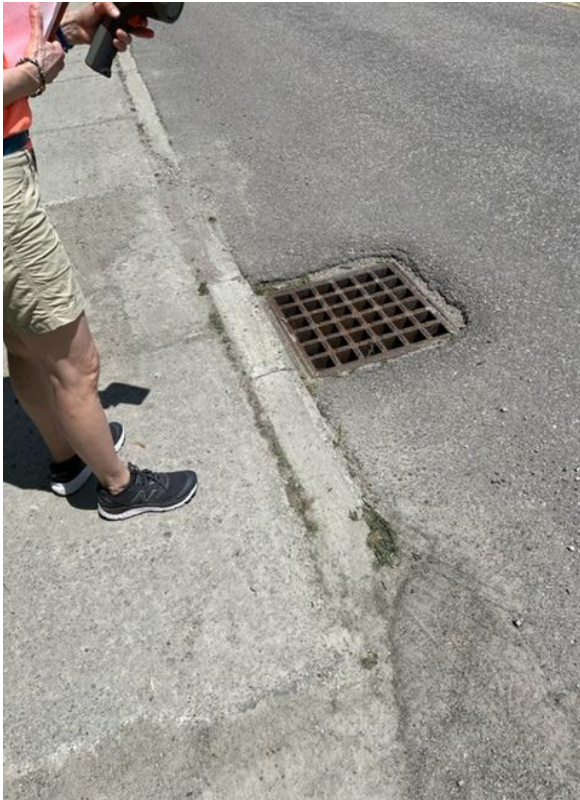
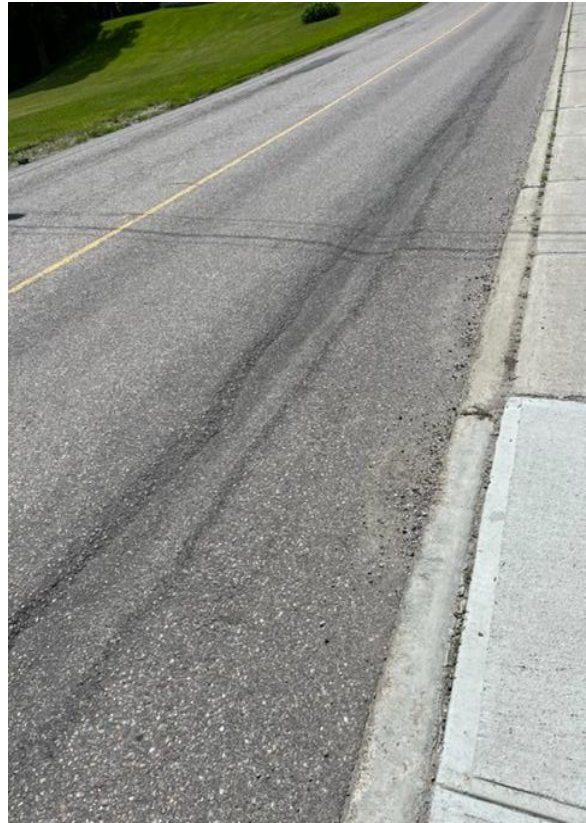
Below-grade storm drain & poor road quality present challenging for bikes

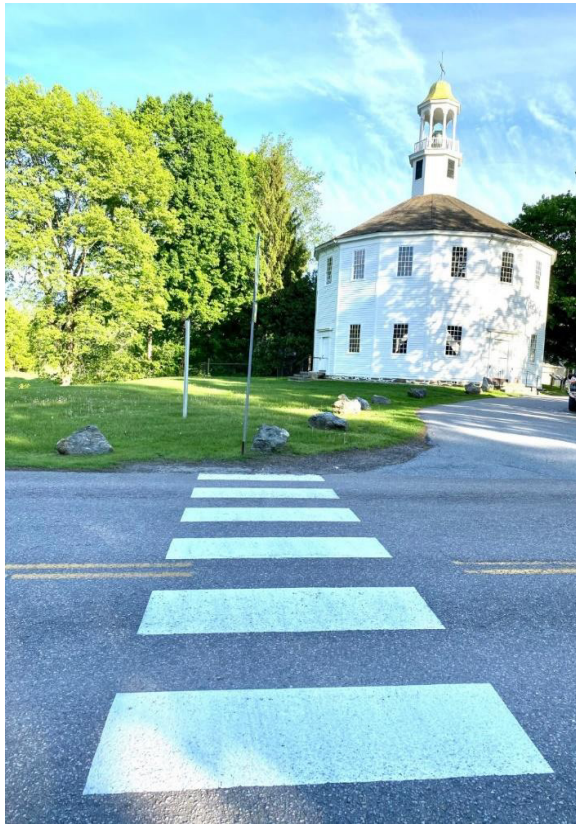
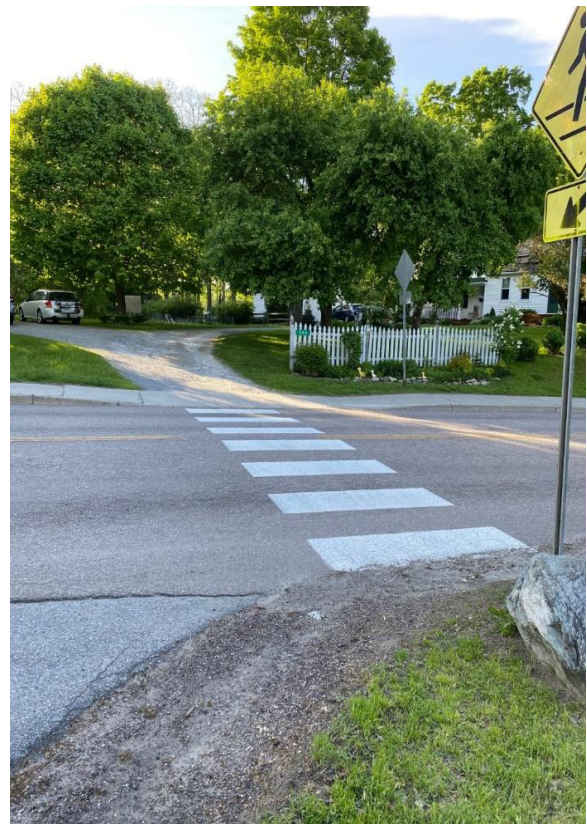
Drivers were observed using left-turn signals when driving straight from Bridge Street to Thompson Road, and some drivers get stalled at the stop signs at Thompson Road and Cochran Road unsure when they can drive. Some drivers appear to be confused about how to drive through the intersection. Drivers were observed not stopping for pedestrians at the crosswalk at this complicated intersection.

Vehicles move quickly through the intersection from Bridge Street to Huntington Road, and vice versa. In addition, drivers were observed driving through the stop sign from Cochran Road onto Bridge Street without stopping. Drivers were also observed not stopping for pedestrians at the crosswalk on Huntington Road.
