Town of Richmond VT: Strategic Roof Replacement Impact & Environmental Assessment

Richmond VT, Town Hall Assessment

Prepared By
Nick Giangarra

November 15, 2024

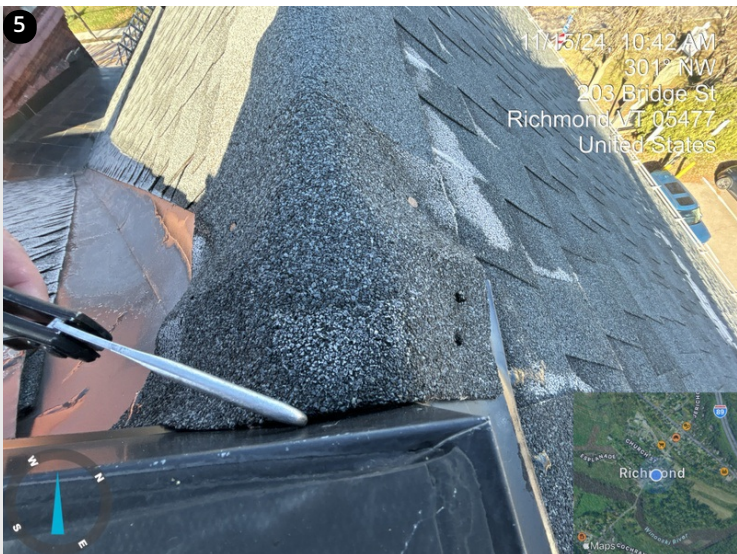
Open area along ridge cap junction.

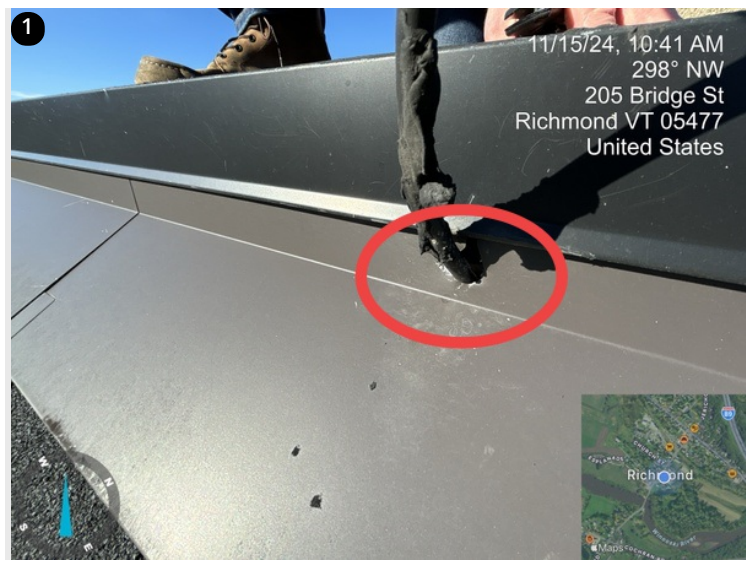
Improperly flashed penetration.

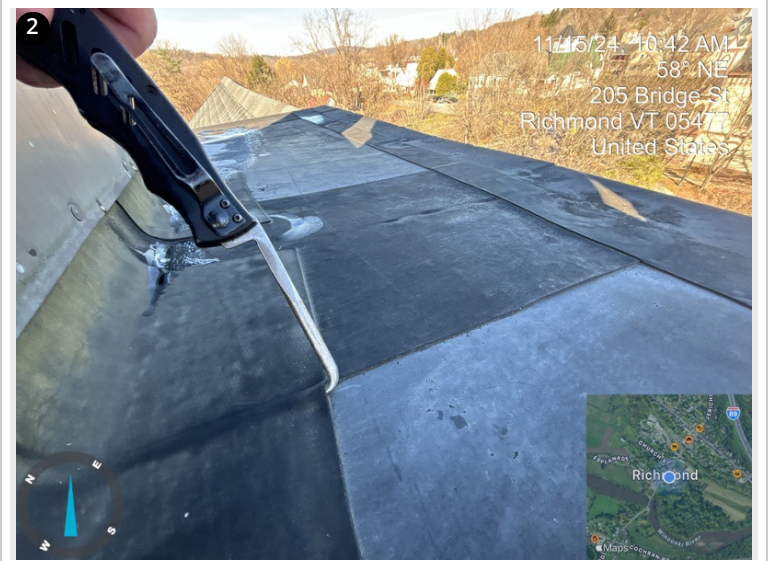
Open conditions surrounding flashing strips.

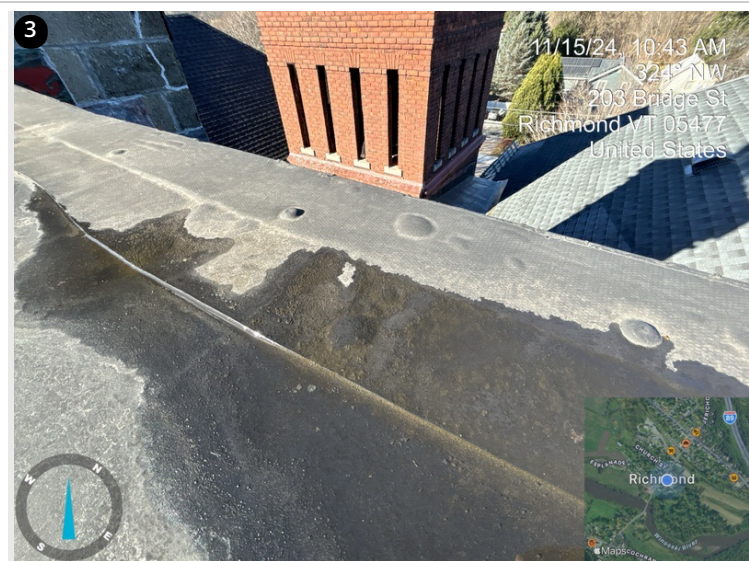
Minor ponding areas throughout the roof section. Perimeter flashing strip bubbling.

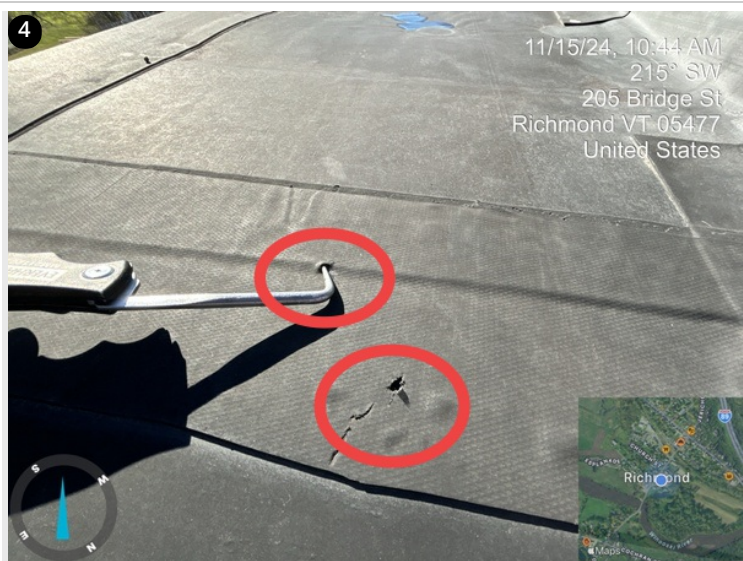
Punctures in the flashing strip.

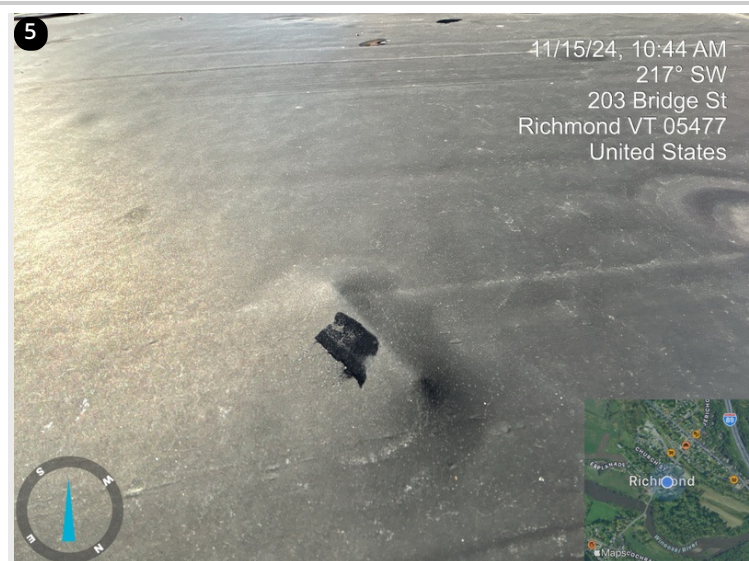
Fastener not fastened through the fastener plate.

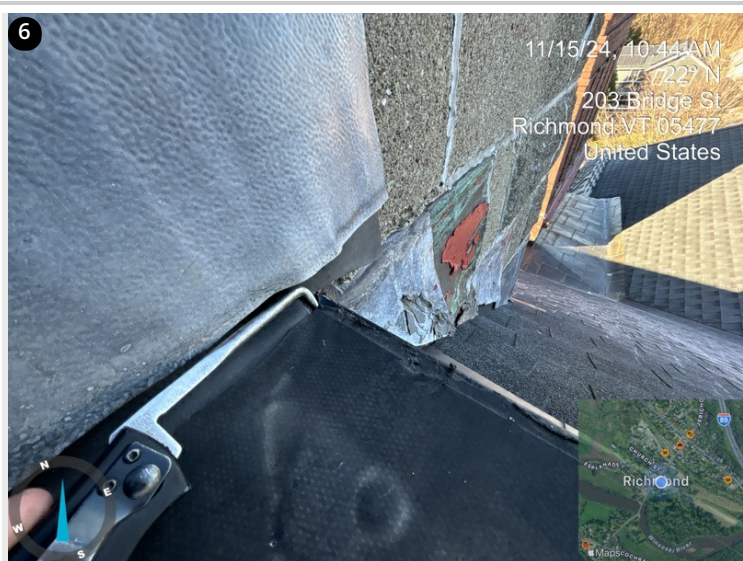
Corner flashing showing minor open conditions.

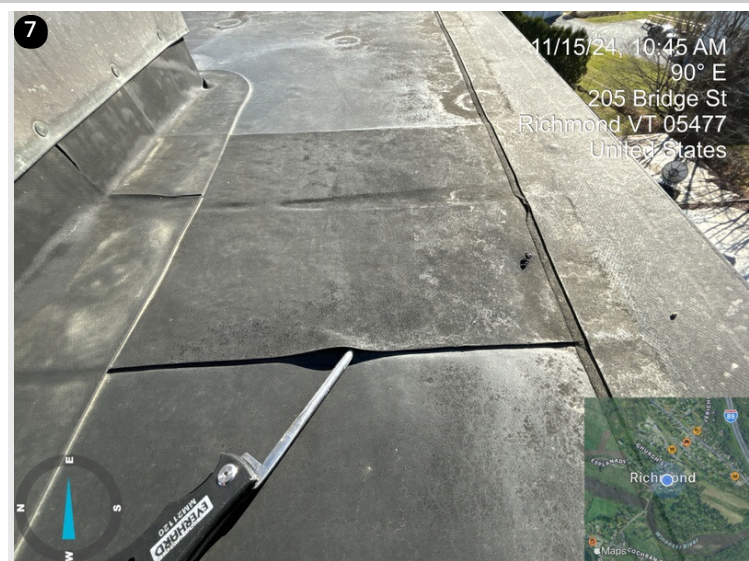
Flashing strip losing adhesion.

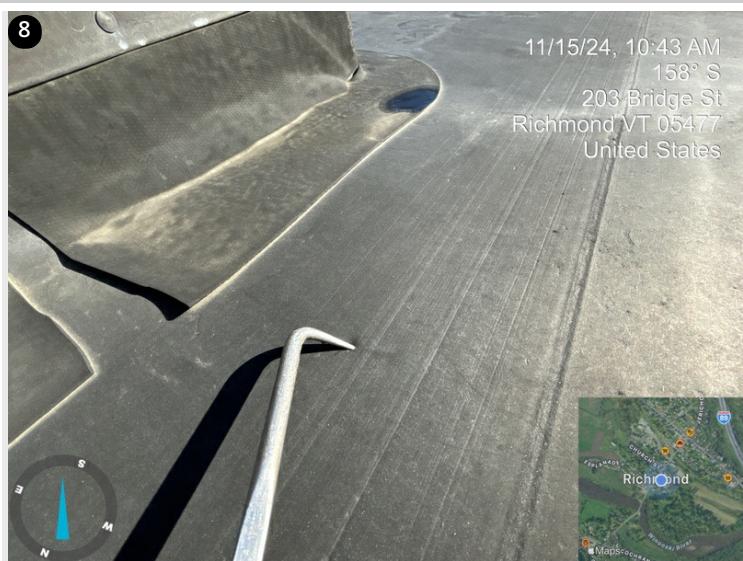
Puncture in the EPDM membrane.

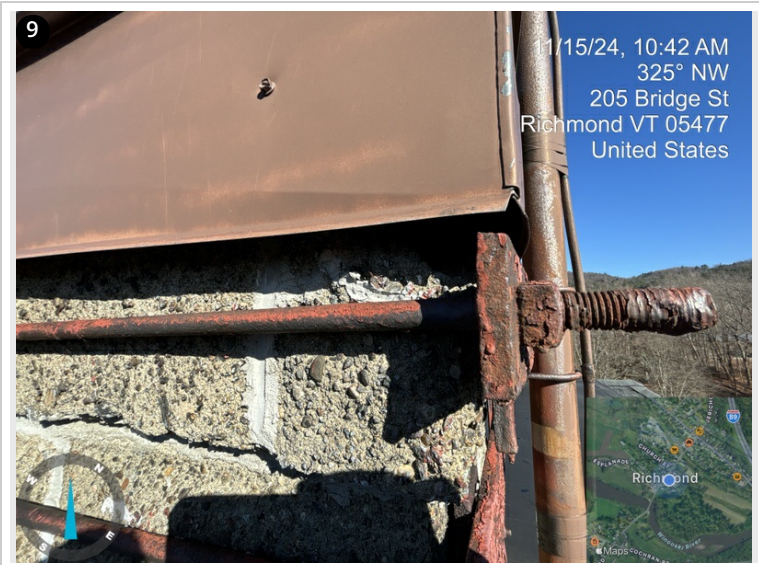
Deteriorated masonry throughout. Corrosion on the metal components attached to the chimney.

1. Brick Repointing: Existing deteriorated mortar will be removed to a uniform depth of 3/4", twice the joint width, or until sound mortar – whichever is greatest. Do not damage masonry units during mortar removal. All damaged units must be replaced at no cost to the owner. All mortar must be removed to achieve a uniform depth. Remove fins and excess mortar at top and bottom of head joints by manual chipping or other means as necessary. New mortar will be installed in three (3) 1/4" lifts fully compacted into the joint and tooled to match existing color and profile as closely as possible (mortar color to be approved by owner).

3. Brick Replacement: Existing spalled or deteriorated brick as well as the surrounding mortar joints will be removed. New brick and mortar will be installed to match the surrounding area as closely as possible (new brick and mortar to be approved by owner prior to installation).

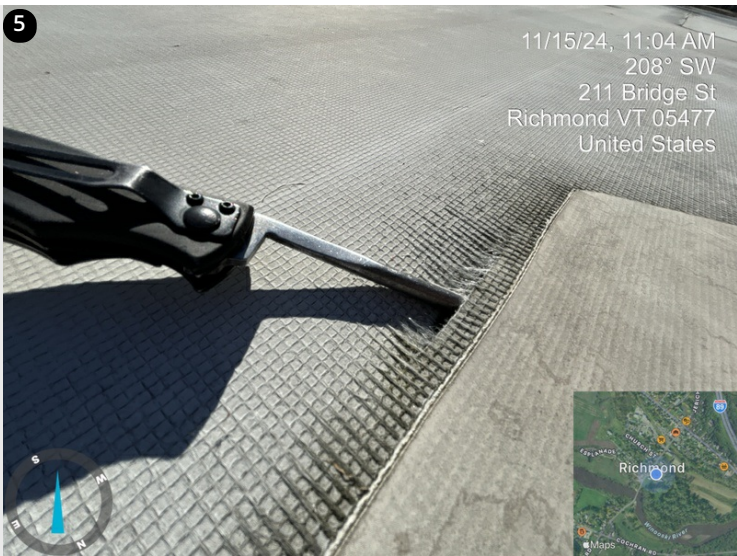
Hole through the degraded single-ply membrane. Exposed scrim throughout the membrane.

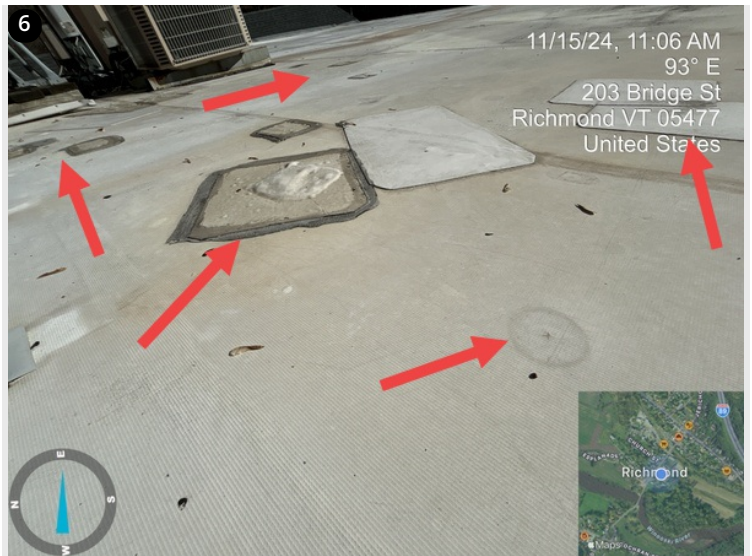
Fastener back out is prevalent throughout the roof sections. Several patches over the fasteners that have already punctured the membrane.

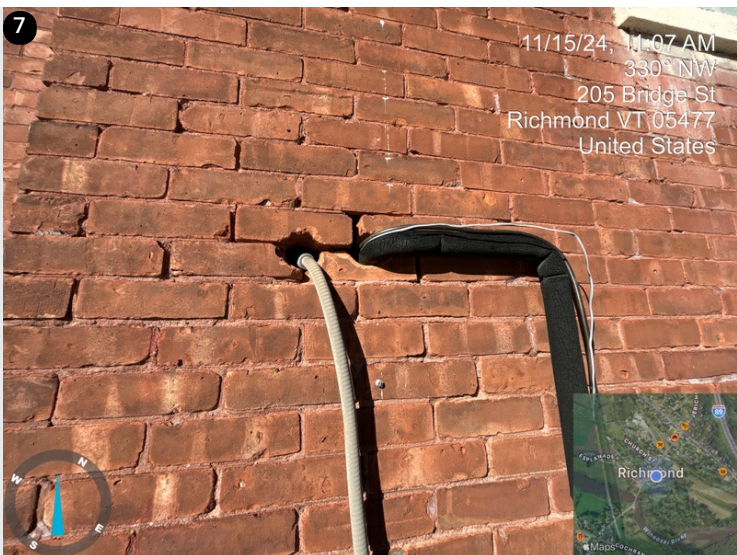
Improperly flashed penetrations in the masonry.

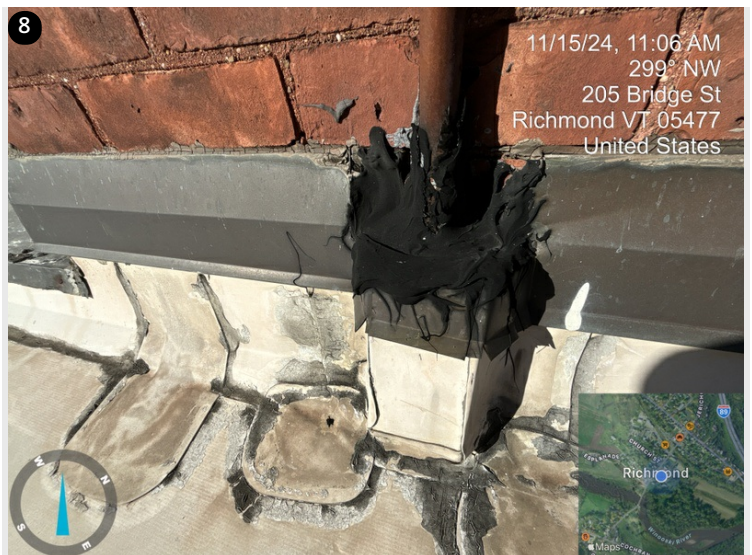
Improperly flashed penetration detail.

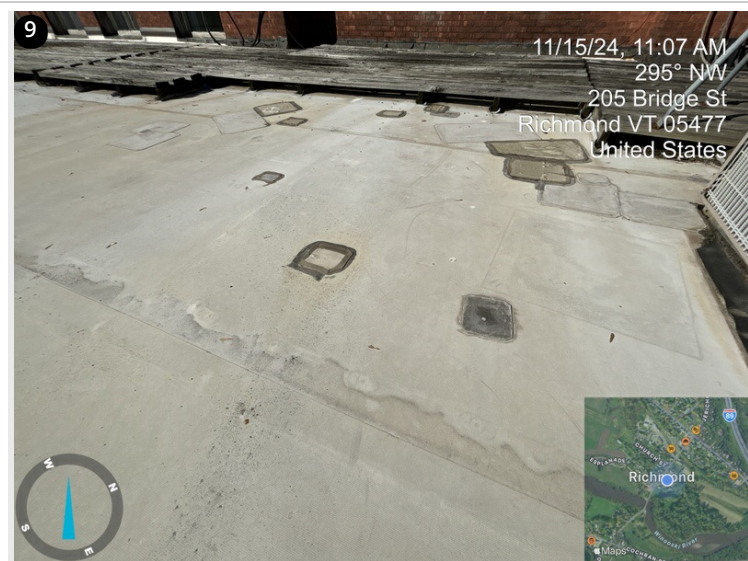
Several previously installed patches throughout the single ply roof system.

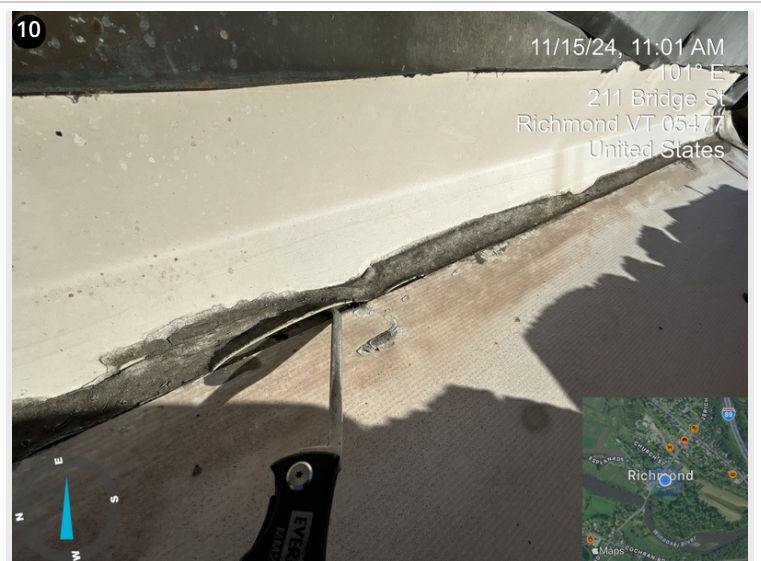
Perimeter flashings are deteriorated and cracked throughout.

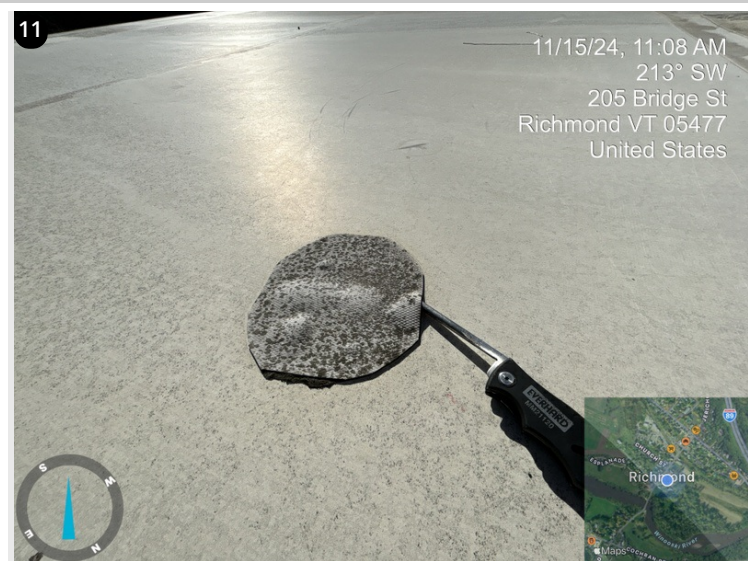
Failing previously installed patch. Incompatible materials (EPDM & TPO).

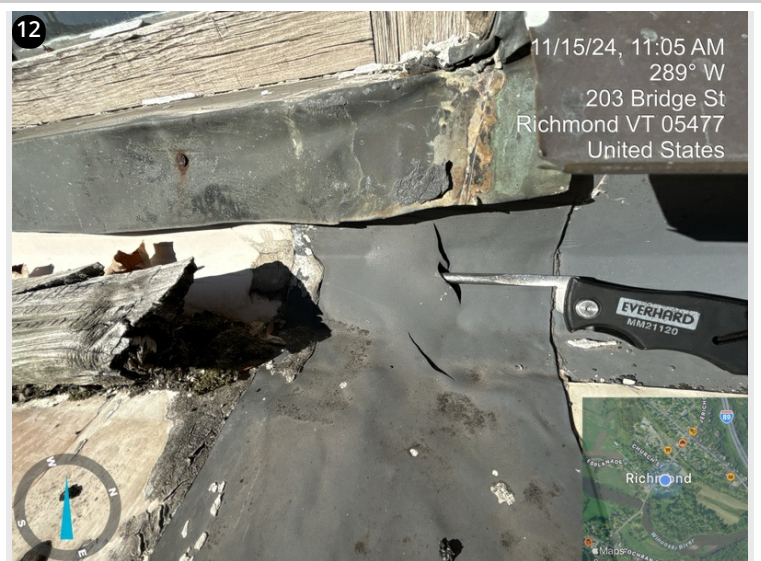
Degraded and split membrane.

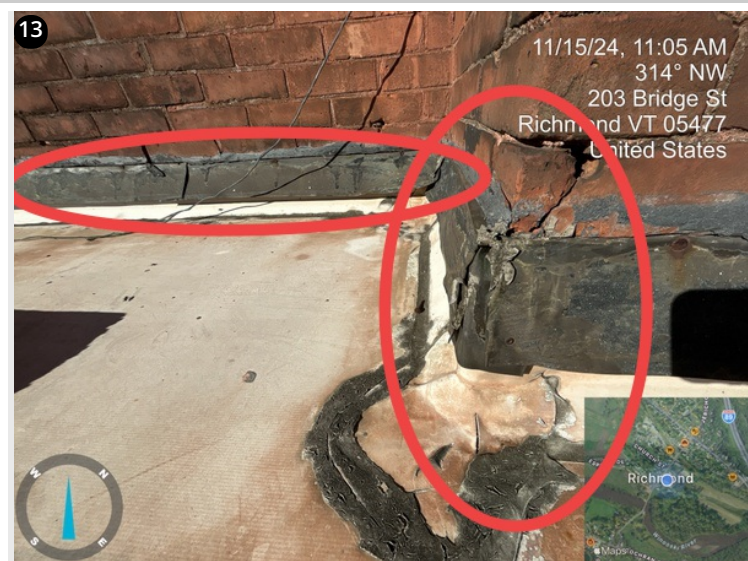
Significant masonry deterioration present throughout. Failing flashings and flashing patches/strips.

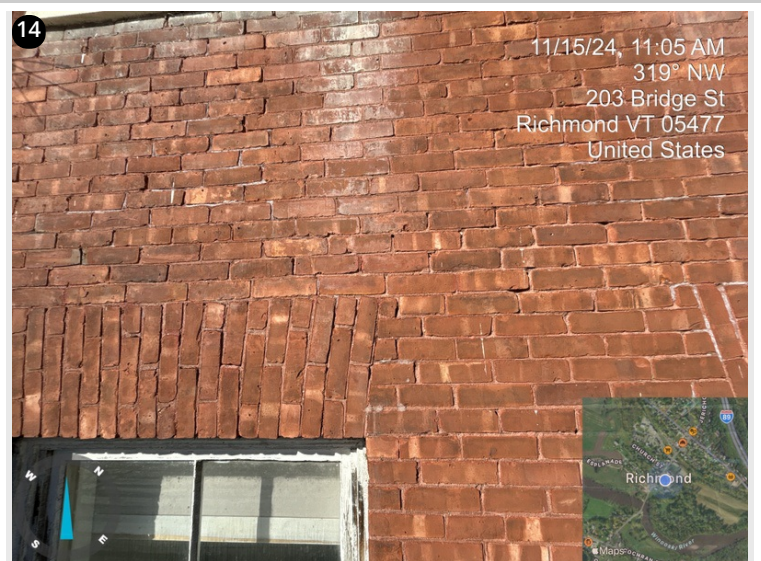
Masonry overview. Deterioration and degradation present throughout.

2. Crack Rout & Caulk: Existing cracks 1/16" (1.5 mm) to 1/8" (3.0 mm) wide shall be routed to a 1/4" x 1/4". Crack shall be cleared of all loose dirt and debris and caulked with elastomeric hybrid sealant in accordance with industry standards and the manufacturer's specifications (new sealant color to be selected by owner from manufacturer's standard color chart).

4. Wash & Water Repellent:
 1. Washing: Specified masonry/stone surfaces shall be washed using high pressure water only.
 2. Water Repellent: After masonry substrates have dried, Seal-A-Pore WB high performance clear silane masonry sealer will be applied according to the manufacturer's specifications.

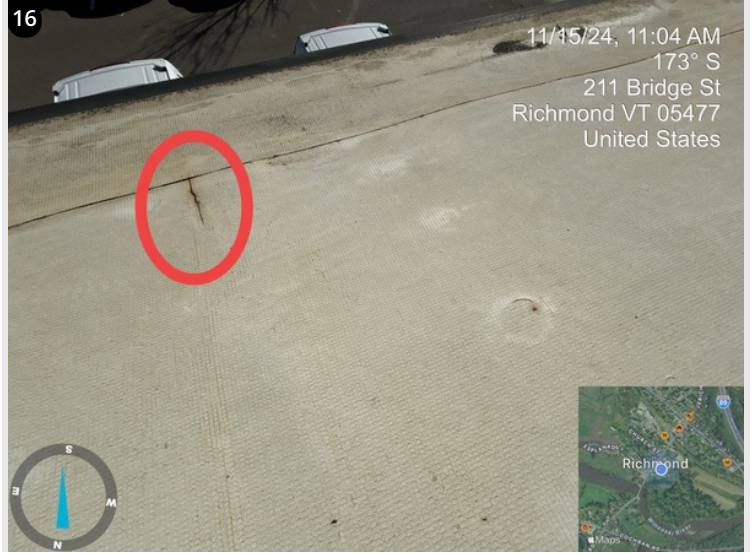
Cracked membrane due to degradation.

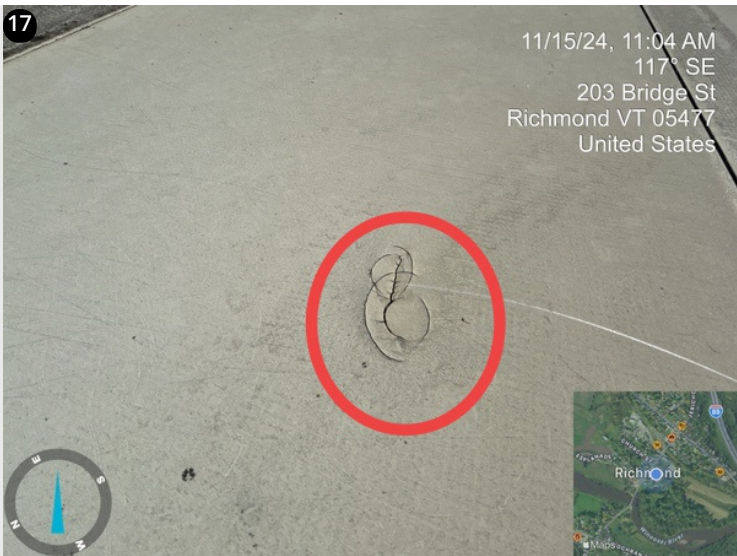
Large hole in the membrane.

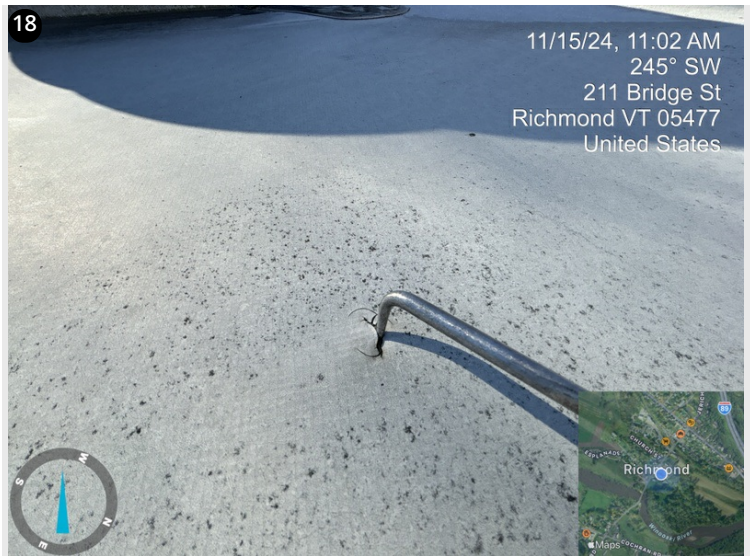
Puncture.

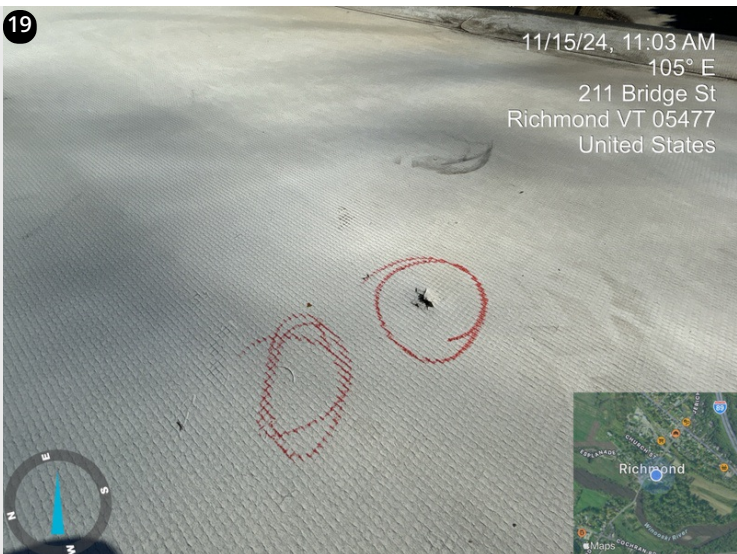
Punctures throughout this failed roof system.

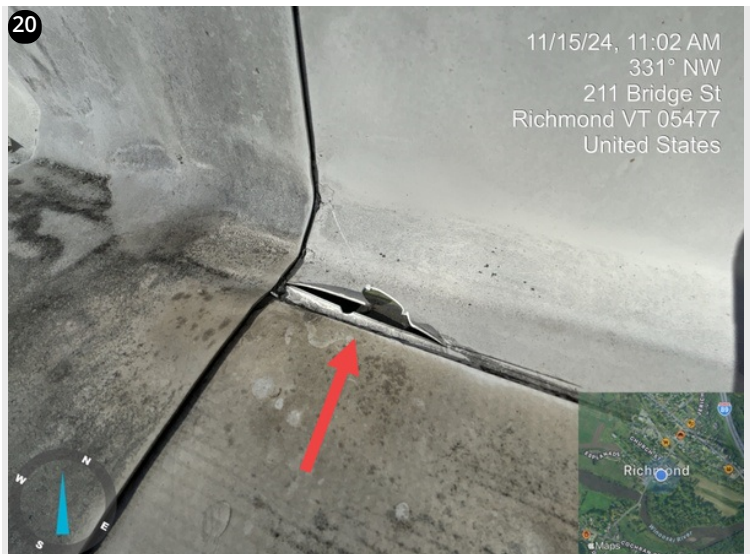
Failed flashing section. Membrane is brittle and is cracking and chipping away.

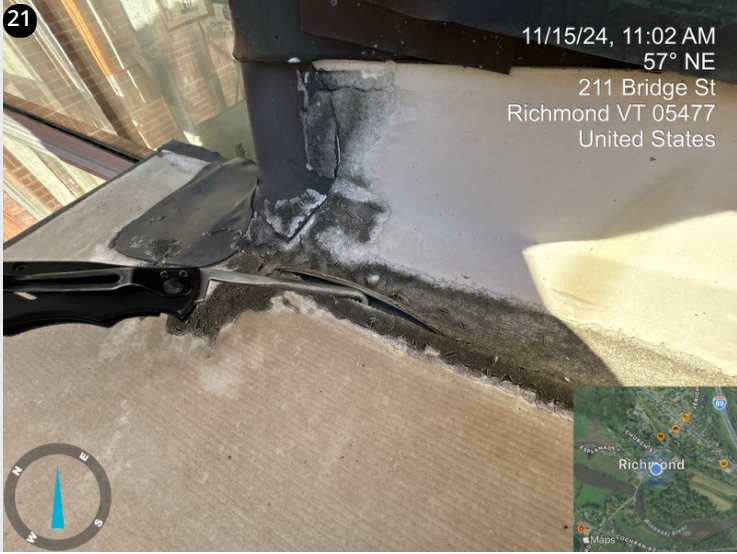
Split in the membrane at a vertical transition.

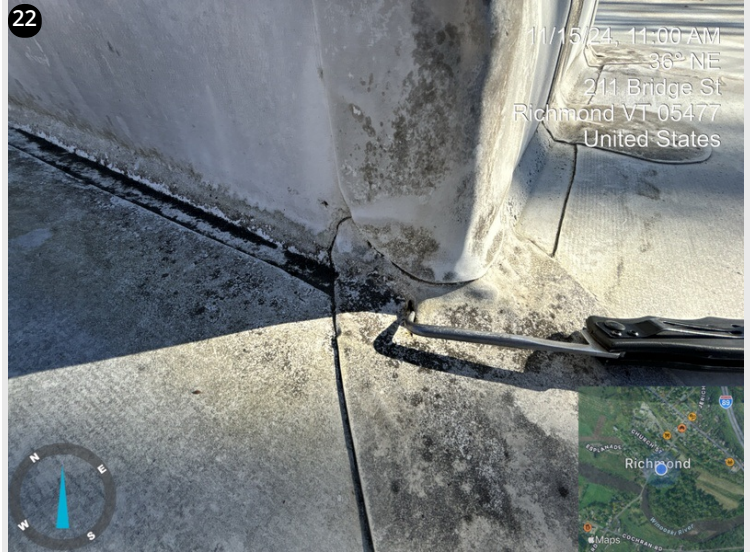
Puncture in curb corner.

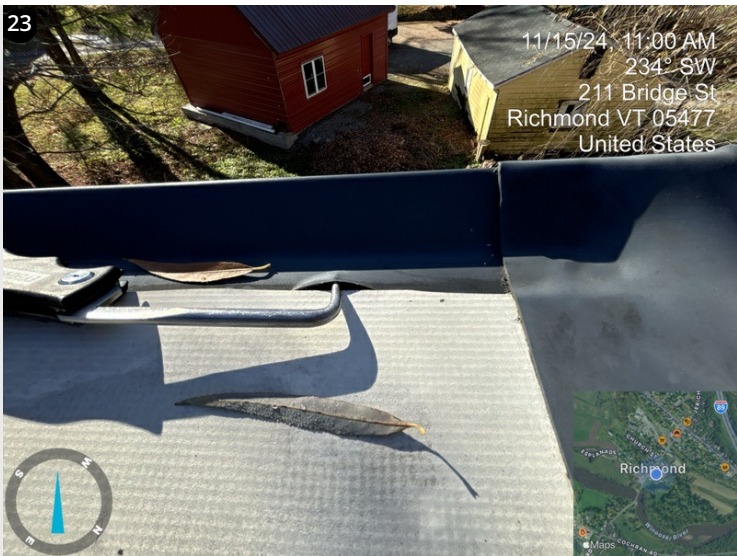
Temporary flashing along perimeter is starting to lose adhesion.

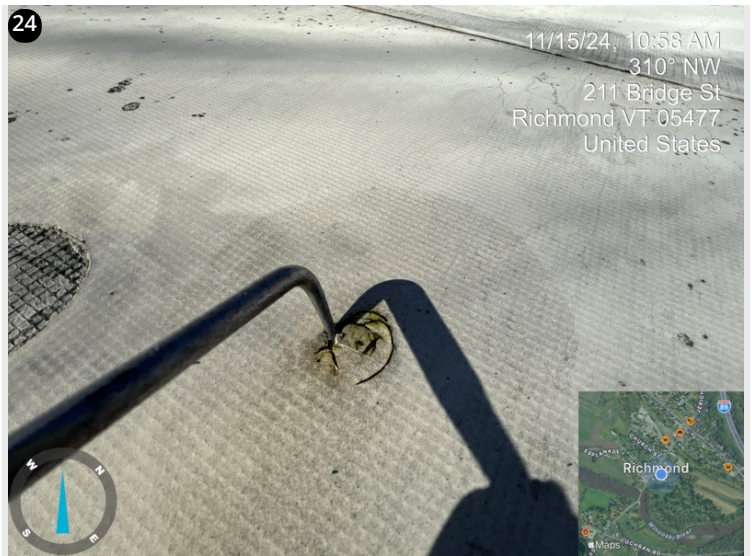
Hole in membrane.
