INFRASTRUCTURE MANAGEMENT

Report Date: 11/14/2023

Account Name: Richmond Water Resources
Asset Name: 750KG (2) Celled
Type of Tank: Finished Water
Dimensions: 47' x 47' x 25' deep.
Address: 281 Esplanade St, Richmond, VT 05477, USA
Latitude: 44.40382
Longitude: -73.000713
Services: Clean (Sediment Removal)|Inspection|Mixer Install
Tank Identification Plate:

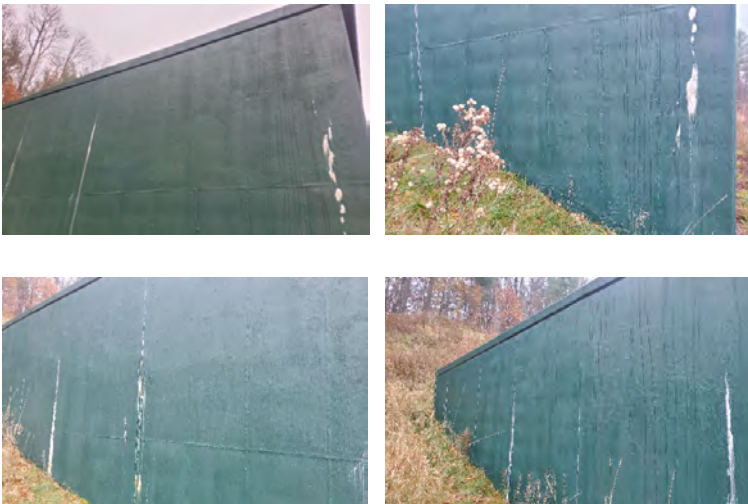
North Wall Exterior Aesthetics Photos

NORTH WALL	
Aesthetics	Mildew
Condition of Protective Coating	Decline/Thinning

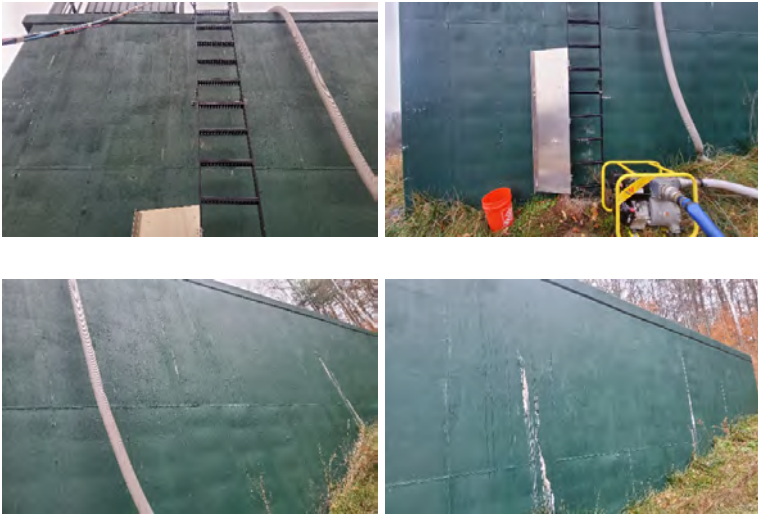
South Wall Exterior Aesthetics Photos

SOUTH WALL	
Aesthetics	Mildew
Condition of Protective Coating	Decline/Thinning

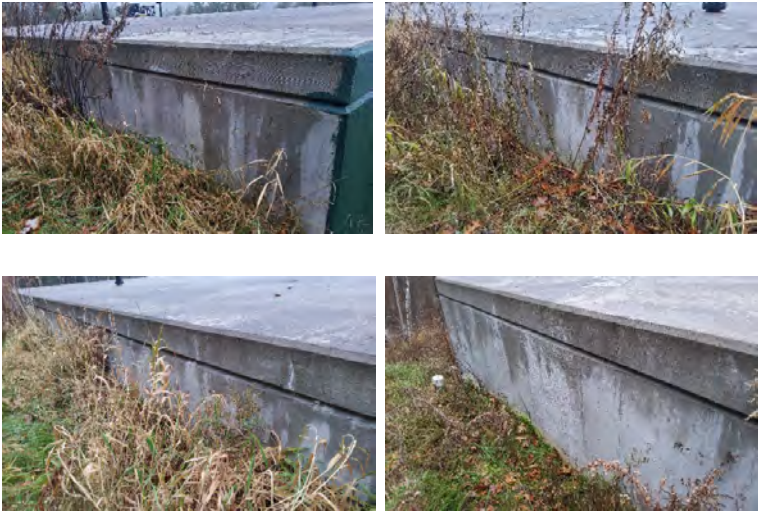
East Wall Exterior Aesthetics Photos

EAST WALL	
Aesthetics	Mildew
Condition of Protective Coating	Decline/Thinning

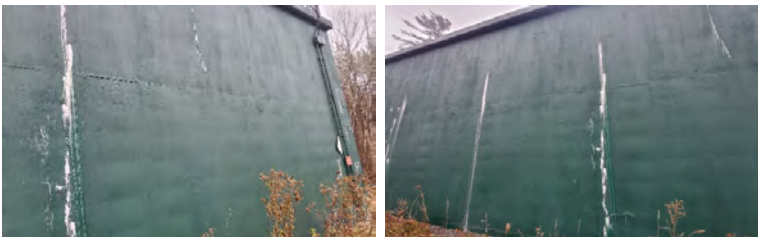
West Wall Exterior Aesthetics Photos

WEST WALL	
Aesthetics	Mildew
Condition of Protective Coating	Decline/Thinning

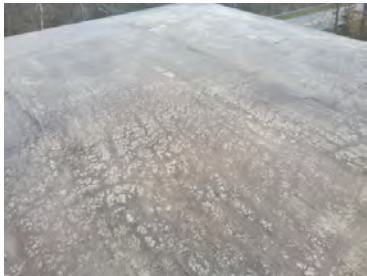
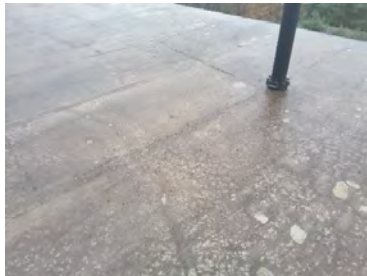
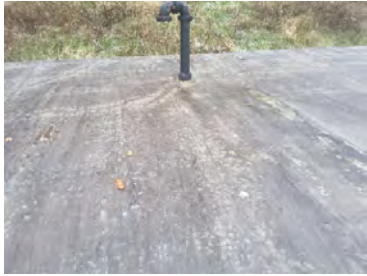
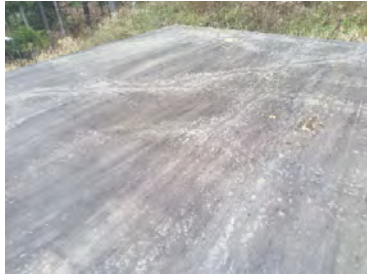
North Roof Quadrant Aesthetic Photos

NORTH ROOF QUADRANT AESTHETICS	
Aesthetic Deficiencies	Mildew
Condition of Protective Coating	Decline/Thinning

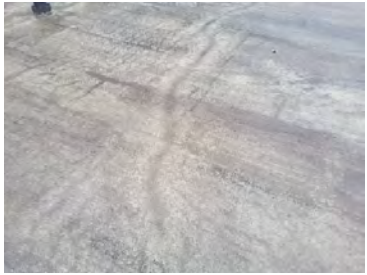
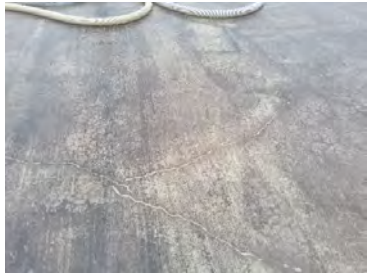
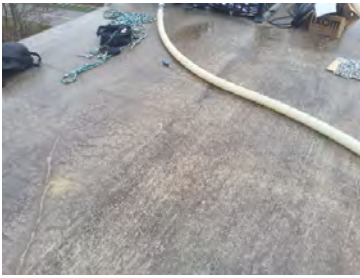
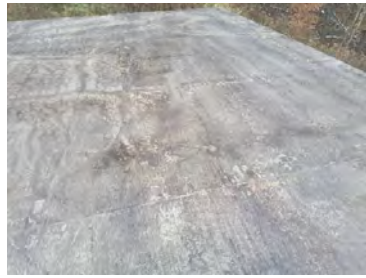
South Roof Quadrant Aesthetic Photos

SOUTH ROOF QUADRANT AESTHETICS	
Aesthetic Deficiencies	Mildew
Condition of Protective Coating	Decline/Thinning

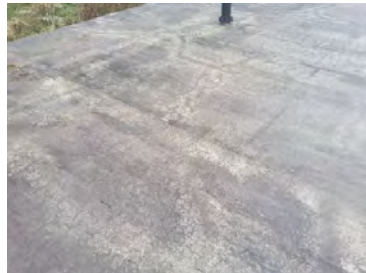
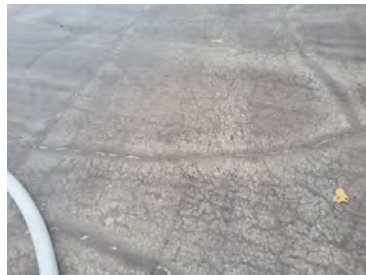
East Roof Quadrant Aesthetics Photos

EAST ROOF QUADRANT AESTHETICS	
Aesthetic Deficiencies	Mildew
Condition of Protective Coating	Decline/Thinning

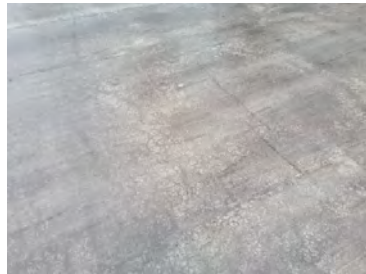
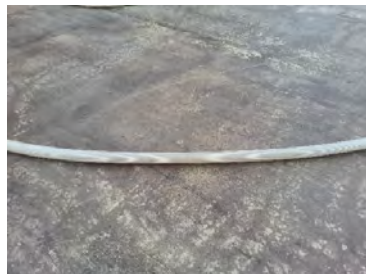
West Roof Quadrant Aesthetics Photos

WEST ROOF QUADRANT AESTHETICS	
Aesthetic Deficiencies	Mildew
Condition of Protective Coating	Decline/Thinning

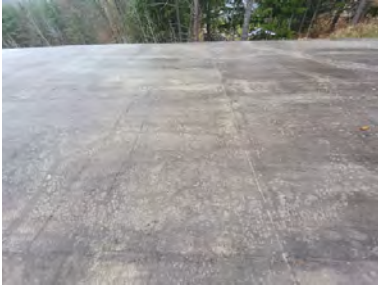
Overall Photo of North Roof Quadrant

Are there any signs of cracks?	Yes
Percent (%) of cracks in this quadrant	Less than 5%
Do any of these cracks have efflorescence?	Yes
Percent (%) of cracks having efflorescence	Less than 5%
Do any of these cracks have depth?	No
Do any of these cracks have width?	No
Are these cracks sealed?	No
Using a sounding hammer throughout this quadrant were any areas of voiding found?	No
Were any areas of spall evident?	No
Are all penetrations sealed?	Yes

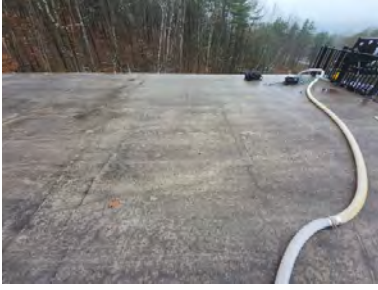
Overall Photo of South Quadrant

Are there any signs of cracks?	Yes
Percent (%) of cracks in this quadrant	Less than 5%
Do any of these cracks have efflorescence?	Yes
Percent (%) of cracks having efflorescence	Less than 5%
Do any of these cracks have depth?	No
Do any of these cracks have width?	No
Are these cracks sealed?	No
Using a sounding hammer throughout this quadrant were any areas of voiding found?	No
Were any areas of spall evident?	No
Are all penetrations sealed?	Yes

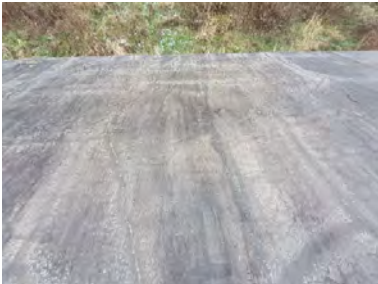
Overall Photo of East Quadrant

EAST ROOF STRUCTURAL	
Are there any signs of cracks?	Yes
Percent (%) of cracks in this quadrant	Less than 5%
Do any of these cracks have efflorescence?	Yes
Percent (%) of cracks having efflorescence	Less than 5%
Do any of these cracks have depth?	No
Do any of these cracks have width?	No
Are these cracks sealed?	No
Using a sounding hammer throughout this quadrant were any areas of voiding found?	No
Were any areas of spall evident?	No
Are all penetrations sealed?	Yes

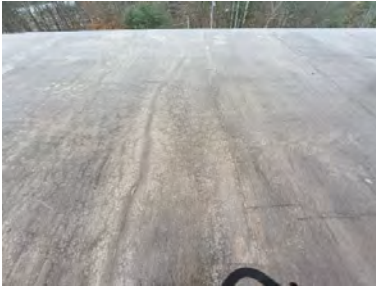
Overall Photo of West Quadrant

WEST ROOF STRUCTURAL	
Are there any signs of cracks?	Yes
Percent (%) of cracks in this quadrant	Less than 5%
Do any of these cracks have efflorescence?	Yes
Percent (%) of cracks having efflorescence	Less than 5%
Do any of these cracks have depth?	No
Do any of these cracks have width?	No
Are these cracks sealed?	No
Using a sounding hammer throughout this quadrant were any areas of voiding found?	No
Were any areas of spall evident?	No
Are all penetrations sealed?	Yes

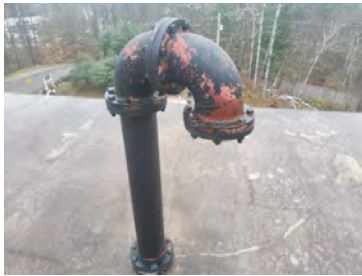
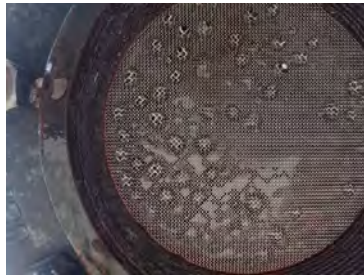
Vent 1 Photos

VENT #1	
Location #1	Northwest
Location #2	Roof
Is this vent coated?	Yes
What is the condition of the coating?	Decline/Thinning
Is this vent downturned?	Yes
Is this vent at least 24" or 3 pipe diameters above the roof?	Yes
Does this vent have a screen?	Yes
What size mesh screen does it have?	24
Is this screen secure?	Yes
Does this screen have any deficiencies?	No
Is the vent a vacuum/pressure release pallet vent?	No

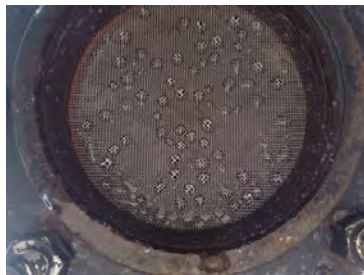
Vent #2 Photos

VENT #2	
Location #1	Northeast
Location #2	Roof
Is this vent coated?	Yes
What is the condition of the coating?	Decline/Thinning
Is this vent downturned?	Yes
Is this vent at least 24" or 3 pipe diameters above the roof?	Yes
Does this vent have a screen?	Yes
What size mesh screen does it have?	24
Is this screen secure?	Yes
Does this screen have any deficiencies?	No
Is the vent a vacuum/pressure release pallet vent?	No

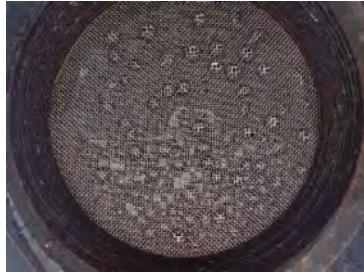
Vent #3 Photos

VENT #3	
Location #1	Southeast
Location #2	Roof
Is this vent coated?	Yes
What is the condition of the coating?	Decline/Thinning
Is this vent downturned?	Yes
Is this vent at least 24" or 3 pipe diameters above the roof?	Yes
Does this vent have a screen?	Yes
What size mesh screen does it have?	24
Is this screen secure?	Yes
Does this screen have any deficiencies?	No
Is the vent a vacuum/pressure release pallet vent?	No

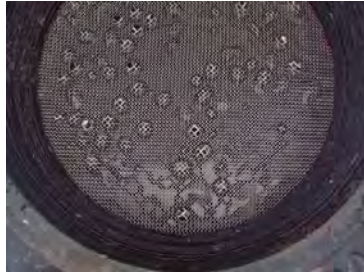
Vent #4 Photos

VENT #4	
Location #1	Southwest
Location #2	Roof
Is this vent coated?	Yes
What is the condition of the coating?	Decline/Thinning
Is this vent downturned?	Yes
Is this vent at least 24" or 3 pipe diameters above the roof?	Yes
Does this vent have a screen?	Yes
What size mesh screen does it have?	24
Is this screen secure?	Yes
Does this screen have any deficiencies?	No
Is the vent a vacuum/pressure release pallet vent?	No

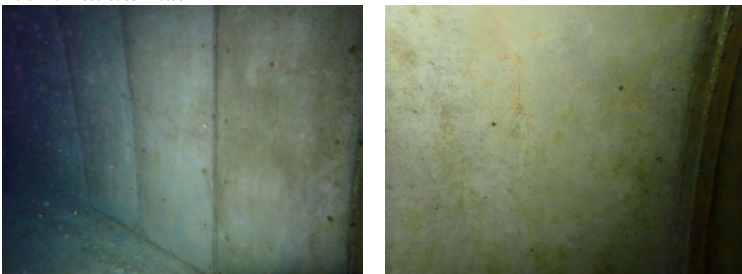
North Wall Aesthetics Photos

INTERIOR AESTHETICS NORTH WALL	
Is there Biofilm/Staining in this quadrant?	Yes
Severity of biofilm/staining?	Mild
Is this quadrant coated?	No

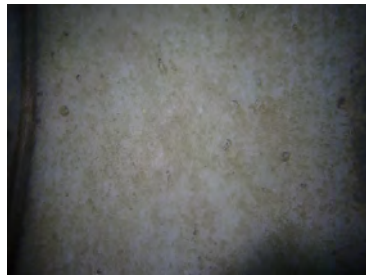
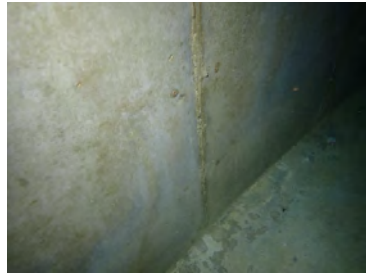
South Wall Aesthetics Photos

Is there Biofilm/Staining in this quadrant?	Yes
Severity of biofilm/staining?	Mild
Is this quadrant coated?	No

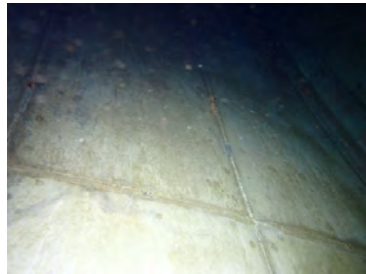
East Wall Aesthetics Photos

Is there Biofilm/Staining in this quadrant?	Yes
Severity of biofilm/staining?	Mild
Is this quadrant coated?	No

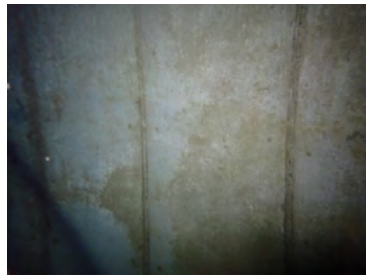
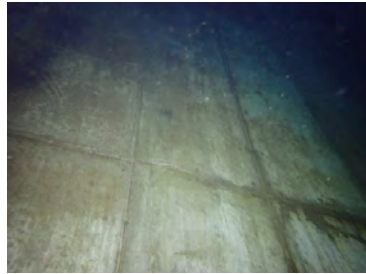
West Wall Aesthetics Photos

Is there Biofilm/Staining in this quadrant?	Yes
Severity of biofilm/staining?	Mild
Is this quadrant coated?	No

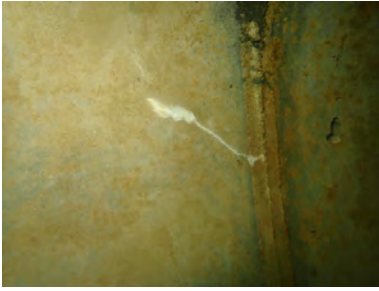
Photos of cracks

Are there any signs of cracks?	Yes
Percent (%) of cracks in this quadrant	5% -10%
Do any of these cracks have efflorescence?	Yes
Percent (%) of cracks having efflorescence:	Less than 5%
Do any of these cracks have depth?	No
Do any of these cracks have width?	No
Are these cracks sealed?	No
Were any areas of spall evident?	No
Additional Notes	5% corrosion nodules

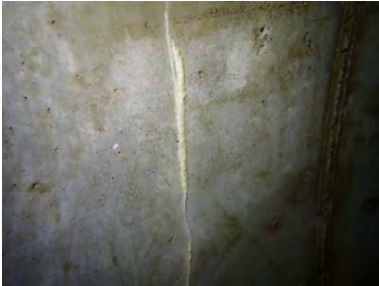
Photos of cracks

Are there any signs of cracks?	Yes
Percent (%) of cracks in this quadrant	Less than 5%
Do any of these cracks have efflorescence?	Yes
Percent (%) of cracks having efflorescence:	Greater than 20%
Do any of these cracks have depth?	No
Do any of these cracks have width?	No
Are these cracks sealed?	No
Were any areas of spall evident?	No
Additional Notes	5% corrosion modules

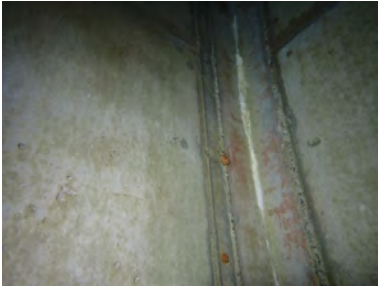
Photos of cracks

Are there any signs of cracks?	Yes
Percent (%) of cracks in this quadrant	5% -10%
Do any of these cracks have efflorescence?	Yes
Percent (%) of cracks having efflorescence:	Greater than 20%
Do any of these cracks have depth?	No
Do any of these cracks have width?	No
Are these cracks sealed?	No
Were any areas of spall evident?	No
Additional Notes	5% corrosion nodules

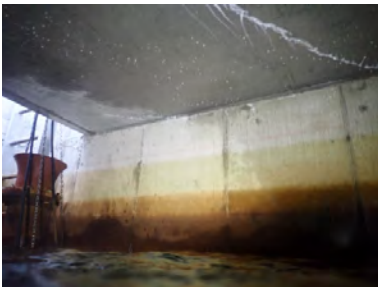
Photos of cracks

Are there any signs of cracks?	Yes
Percent (%) of cracks in this quadrant	Less than 5%
Do any of these cracks have efflorescence?	Yes
Percent (%) of cracks having efflorescence:	Greater than 20%
Do any of these cracks have depth?	No
Do any of these cracks have width?	No
Are these cracks sealed?	No
Were any areas of spall evident?	No
Additional Notes	5% corrosion nodules

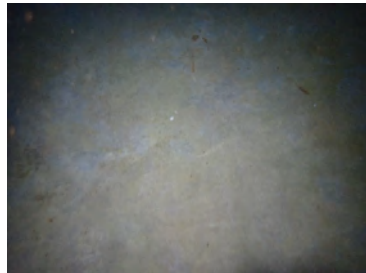
North Floor Aesthetics Photos

INTERIOR AESTHETICS NORTH FLOOR	
Is there Biofilm/Staining in this quadrant?	Yes
Severity of biofilm/staining?	Mild
Is this quadrant coated?	No

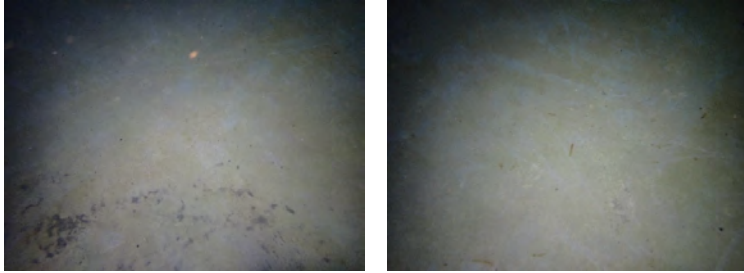
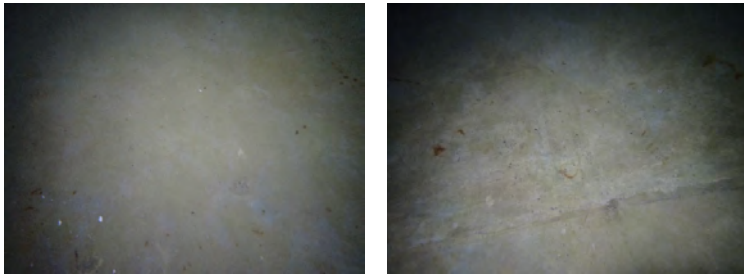
South Floor Aesthetics Photos

INTERIOR AESTHETICS SOUTH FLOOR	
Is there Biofilm/Staining in this quadrant?	Yes
Severity of biofilm/staining?	Mild
Is this quadrant coated?	No

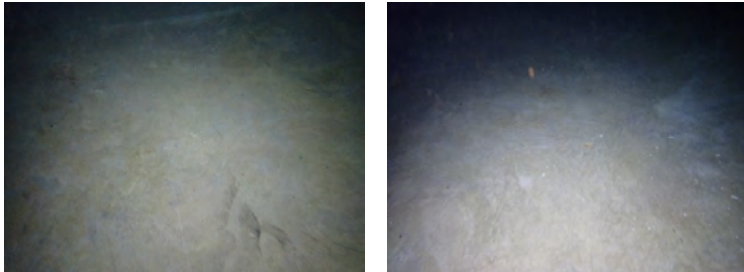
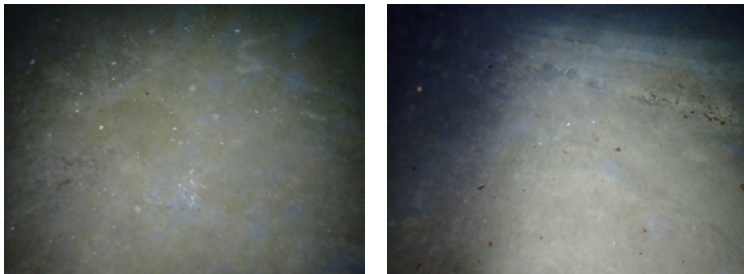
East Floor Aesthetic Photos

Is there Biofilm/Staining in this quadrant?	Yes
Severity of biofilm/staining?	Mild
Is this quadrant coated?	No

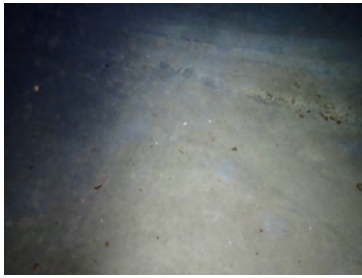
West Floor Aesthetic Photos

Is there Biofilm/Staining in this quadrant?	Yes
Severity of biofilm/staining?	Mild
Is this quadrant coated?	No

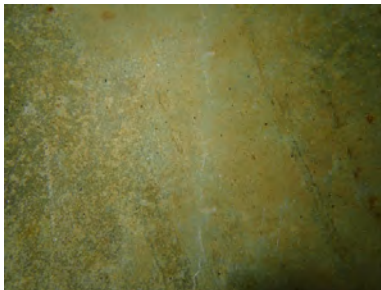
Photos of cracks

INTERIOR STRUCTURAL EAST FLOOR	
Are there any signs of cracks?	Yes
Percent(%) of cracks in this quadrant	Less than 5%
Percent (%) of cracks having efflorescence:	Greater than 20%
Do any of these cracks have depth?	No
Do any of these cracks have width?	No
Are these cracks sealed?	No
Were any areas of spall evident?	No

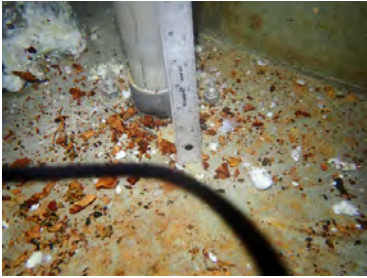
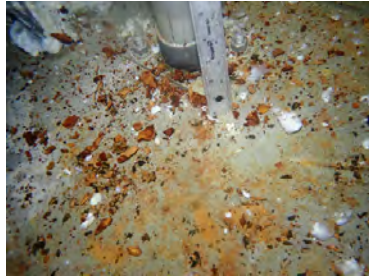
Before Sediment Removal

SEDIMENT REMOVAL	
How much sediment was found on the bottom of this structure? (in inches)	0.03125
Sediment appears to be:	Brown sediment and minor corrosion from ladder and overflow
Was all sediment removed?	Yes

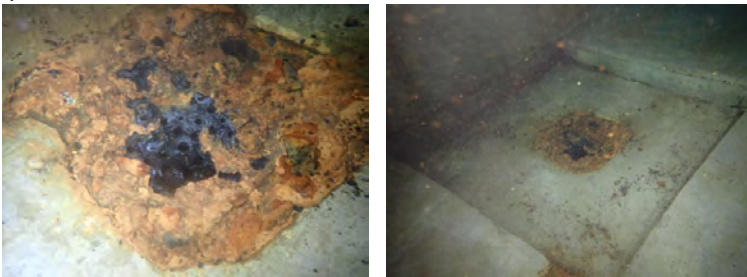
Pipe #2 Photos

Where does this pipe penetrate the structure?	Floor
Does this pipe penetrate from a sump?	Yes
What is the shape of the sump it is penetrating?	Square/Rectangle
What is the width of the sump it is penetrating? (in inches)	36
What is the depth of the sump it is penetrating? (in inches)	4
What is the length of the sump it is penetrating? (in inches)	36
Does this pipe terminate within a sump?	No
What is the diameter of this pipe? (in inches)	12
What is the material of this pipe?	Steel
Is this pipe obstructed?	Yes
What is obstructing this pipe?	Corrosion
Additional notes for obstruction	Drainage grate was covered in corrosion.
Is there anything on the end of this pipe?	Grate
Was there flow at the time of inspection?	No
Is this pipe coated?	Yes
Condition of coating	Decline/Thinning
Is this pipe supported?	No

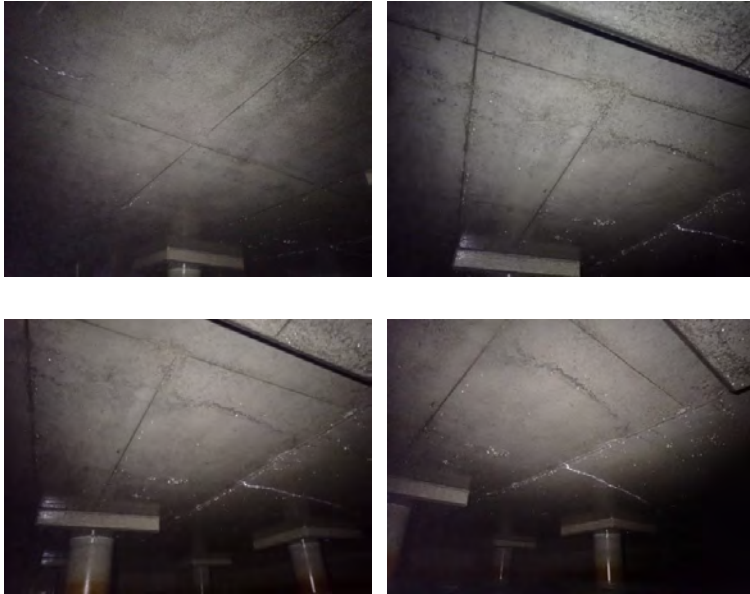
North Overhead Aesthetics Photos

Aesthetic Deficiencies	Mildew
Is this quadrant coated?	No
Is the hatch visible in this quadrant?	No

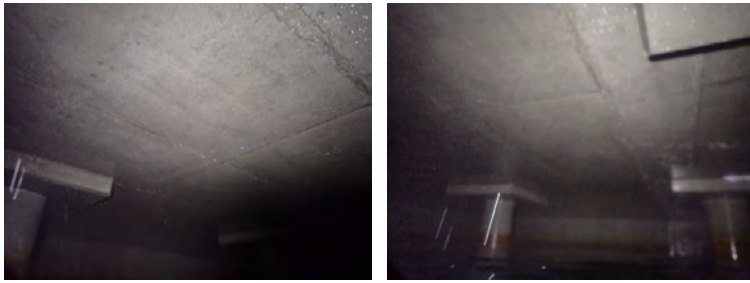
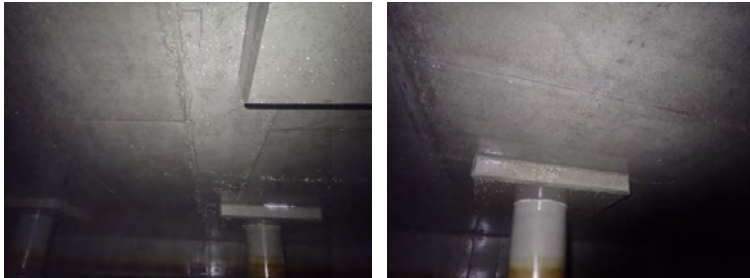
South Overhead Aesthetics Photos

Aesthetic Deficiencies	Mildew
Is this quadrant coated?	No
Is the hatch visible in this quadrant?	No

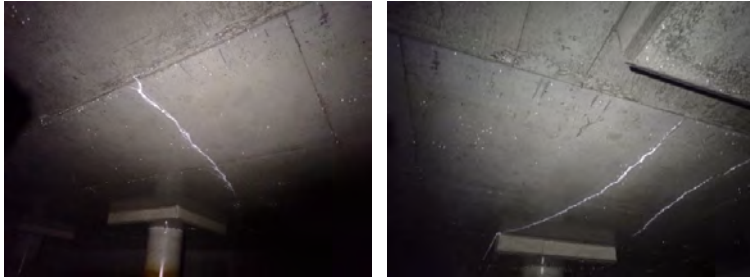
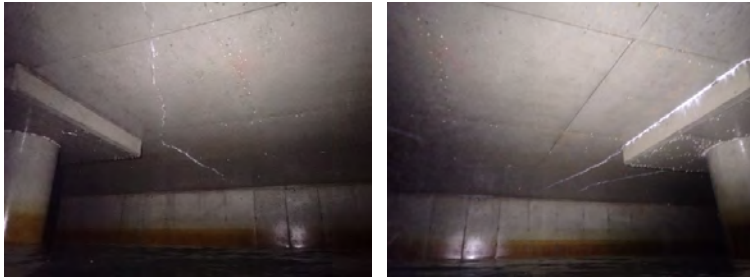
East Overhead Aesthetics - Photos

EAST OVERHEAD AESTHETICS QUADRANT	
Aesthetic Deficiencies	Mildew
Is this quadrant coated?	No
Is the hatch visible in this quadrant?	No

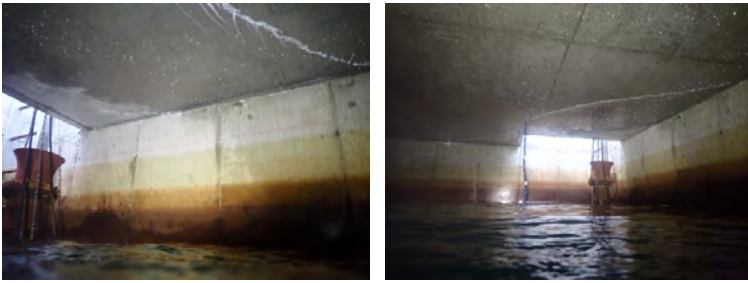
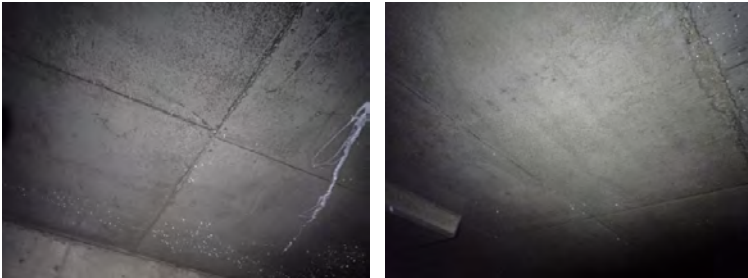
West Overhead Aesthetics Photos

WEST OVERHEAD AESTHETICS QUADRANT	
Aesthetic Deficiencies	Mildew
Is this quadrant coated?	No
Is the hatch visible in this quadrant?	Yes
Interior Hatch Aesthetics	Decline/Thinning

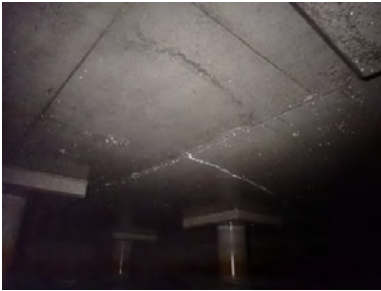
North Overhead Structural - Photos of cracks

Are there any signs of cracks?	Yes
Percent(%) of cracks in this quadrant	5% -10%
Do any of these cracks appear to have efflorescence?	Yes
Percent(%) of cracks having efflorescence:	Greater than 20%
Do any of these cracks appear to have depth?	No
Do any of these cracks appear to have width?	No
Do these cracks appear to be sealed?	No
Were any areas of spall evident?	No

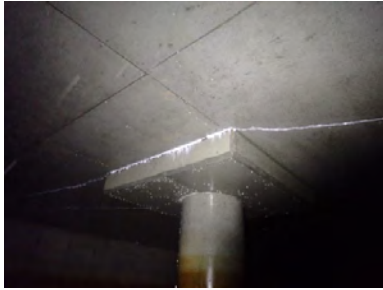
South Overhead Structural - Photos of cracks

Are there any signs of cracks?	Yes
Percent(%) of cracks in this quadrant	5% -10%
Do any of these cracks appear to have efflorescence?	Yes
Percent(%) of cracks having efflorescence:	Greater than 20%
Do any of these cracks appear to have depth?	No
Do any of these cracks appear to have width?	No
Do these cracks appear to be sealed?	No
Were any areas of spall evident?	No

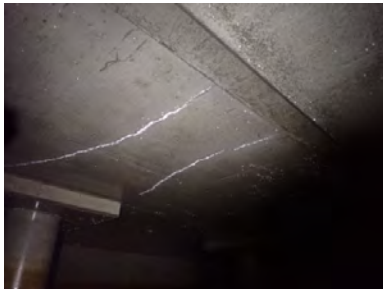
East Overhead Structural - Photos of cracks

Are there any signs of cracks?	Yes
Percent(%) of cracks in this quadrant	5% -10%
Do any of these cracks appear to have efflorescence?	Yes
Percent(%) of cracks having efflorescence:	Greater than 20%
Do any of these cracks appear to have depth?	No
Do any of these cracks appear to have width?	No
Do these cracks appear to be sealed?	No
Were any areas of spall evident?	No

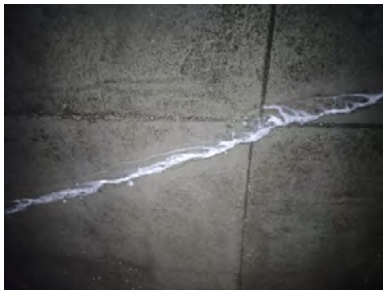
West Overhead Structural - Photos of cracks

Are there any signs of cracks?	Yes
Percent(%) of cracks in this quadrant	5% -10%
Do any of these cracks appear to have efflorescence?	Yes
Percent(%) of cracks having efflorescence:	Greater than 20%
Do any of these cracks appear to have depth?	No
Do any of these cracks appear to have width?	No
Do these cracks appear to be sealed?	No
Were any areas of spall evident?	No
