Memorandum

Re: ***Southview Subdivision Stormwater Project – Soils Investigation***
Attachment A: Southview Subdivision Soil Report
Attachment B: Southview Subdivision Soil Borings Map
Attachment C: Button Underground Locating Field Report

Watershed Consulting is pleased to present this memorandum and summary report to close out Task 4 of the Southview Subdivision Stormwater Project.

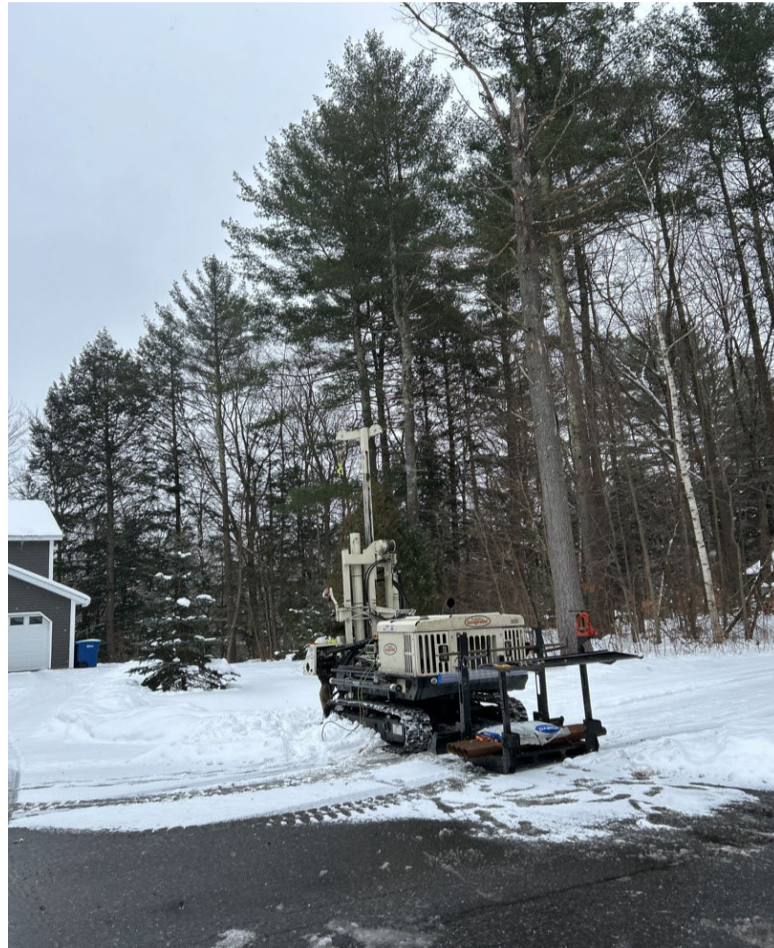
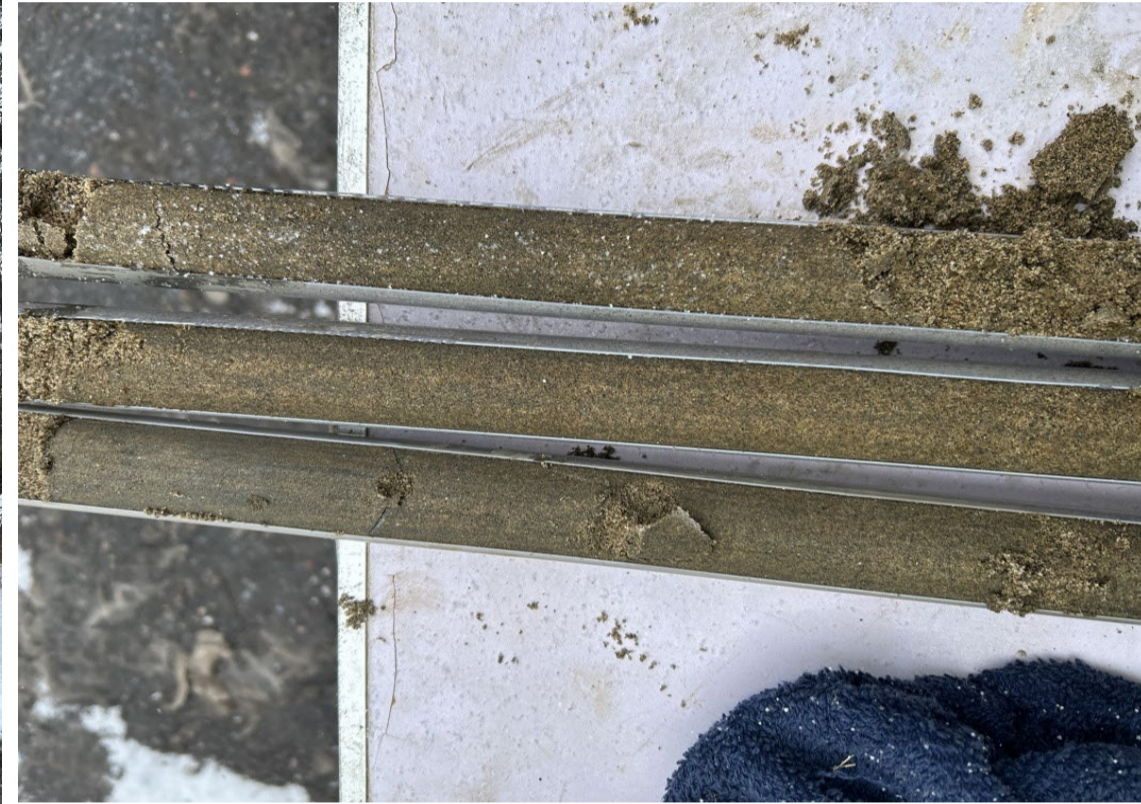
Site Photos

TP-1 was located at the cul-de-sac of Westall Extension near 77 Westall Extension. The boring was completed to a depth of 240". The topsoil layer was rocky and contained many coarse fragments. The entire soil profile consisted of well-draining sand. A seasonal high groundwater table was indicated at 193" in depth due to observed redoximorphic features and small clay lenses. No saturation or groundwater table was detected in the 240" of soil retrieved. NRCS soil maps of the area have this section mapped as Adams and Windsor loamy sands, in Hydrologic Soil Group (HSG) A, which is supported by our field observations. Given the very deep groundwater table and well-draining sand, this area would be well-suited to an infiltrating stormwater feature.

Pit ID: TP-1	
Site Name: Southview Subdivision	
Sampling Method: GeoProbe	Site Location: 84 Westall Ext, Richmond, VT
Excavated Pit Depth: 240"	Excavation Date: 1/15/25
Depth to Water Table: Not observed	Start Time: 12:31 PM
Depth to SHGW: 193"	Representative: AS, AShep
Overall Site Notes:

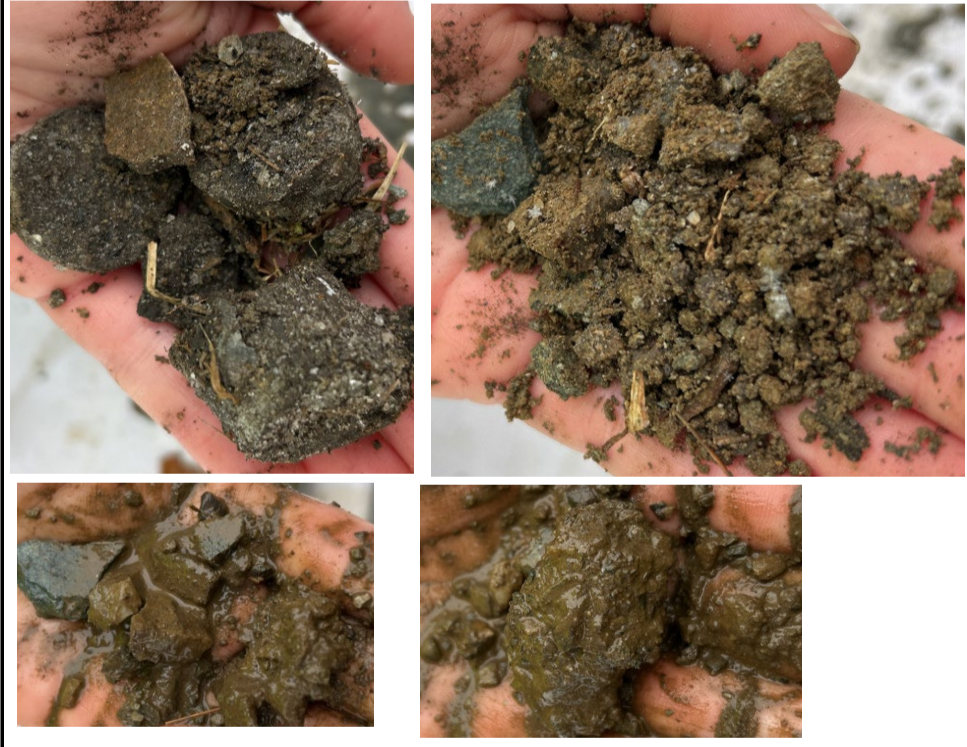
Depth (in)	Soil Texture (USDA)	Soil Color	Coarse Fragments (Quantity & Size)	Redoximorphic Features (Depth, Color and Abundance)	Roots (Quantity & Size)	Soil Structure	Soil Moisture	Additional Notes	Horizon Photos
0-11.5	Sand	Medium brown	Yes, many coarse fragments, avg size 0.5"	No	Yes, some small	Granular (soil aggregates)	Dry	Vegetated overlay, topsoil

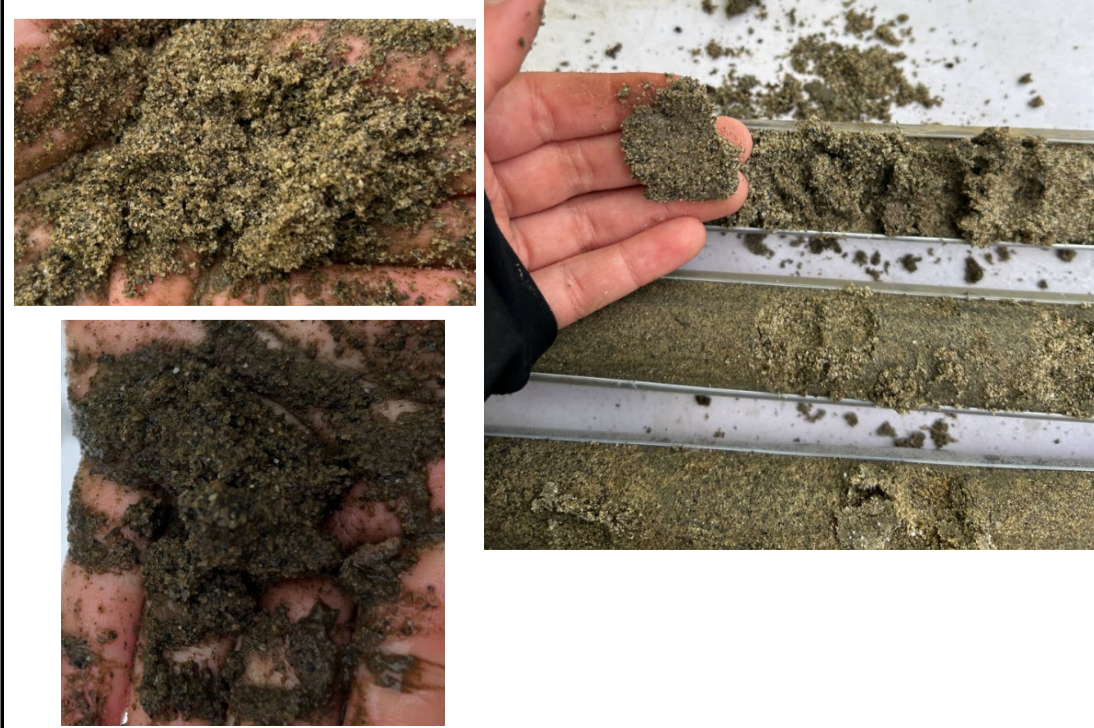
11.5-240	Sand	Light brown, yellow hues	Yes, few coarse fragments, avg size 0.3"	Small amount of redox if any found at 193"	No	Single grain (loose mineral/rock grains)	Dry to slightly moist	<p>Long continuous sand layer, very well drained and not saturated through 15'. High water mark at 193" based on small amount of redox, though dry all the way through. Small plates of denser clay material but not even all the way through core, though potentially slowing some water at 200" down</p>

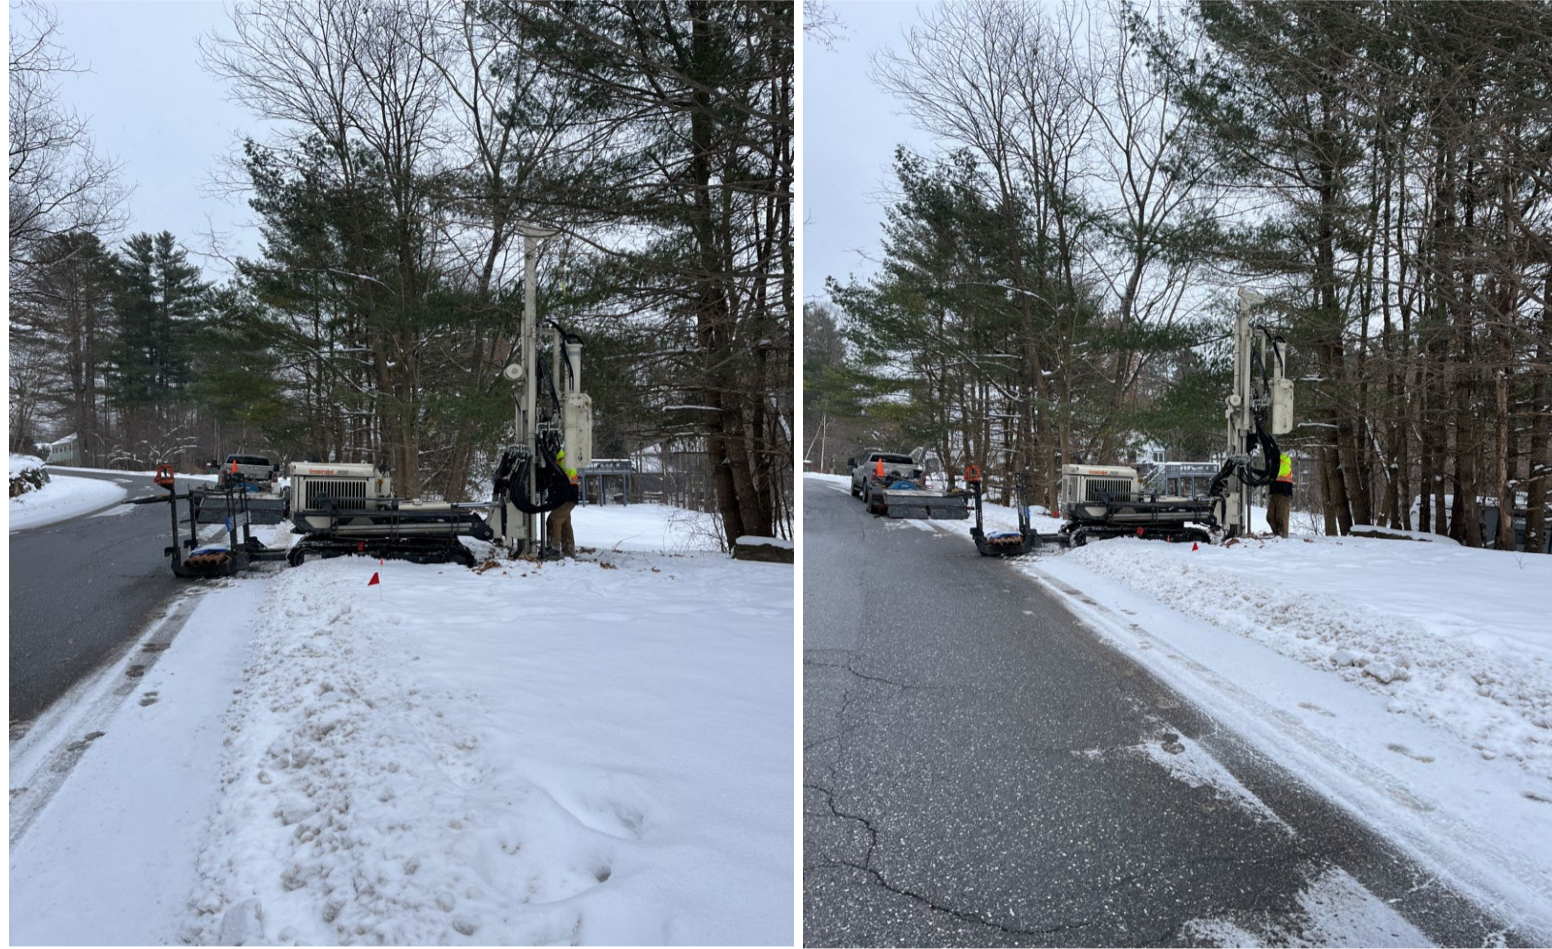
Site Photos

TP-2 was located near 238 Westall Drive outside of an open, undeveloped lot. The boring was completed to a depth of 240". A topsoil layer of loamy sand was identified from 0-9", dry sand from 9-77", and a silt loam layer from 77-88". This silt loam layer was saturated at 80", perhaps functioning as a confining layer. Beneath this layer there were two more layers of sand from 88-142" and 142-240" in depth. Small lenses of clay were identified between the two sand layers at around 142", though the sand was dry. The material became very dense at around 228" in depth, as the auger likely reached the underlying glacial till. This area is also mapped as Adams and Windsor loamy sands (HSG A), which is supported by our field observations. Despite the confining layer, a shallow infiltration practice is still feasible in this area.

Pit ID: TP-2
		Site Name: Southview Subdivision
Sampling Method:	GeoProbe	Site Location: 238 Westall Dr, Richmond, VT
Excavated Pit Depth:	240"	Excavation Date: 1/15/25
Depth to Water Table:	80"	Start Time: 1:00 PM
Depth to SHGW	N/A	Representative: AS, AShep
Overall Site Notes:

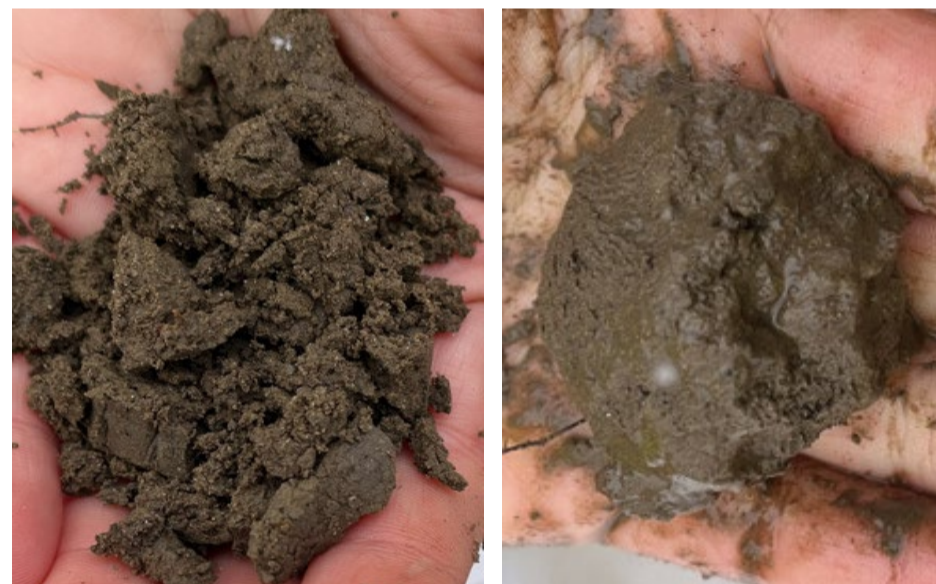
Depth (in)	Soil Texture (USDA)	Soil Color	Coarse Fragments (Quantity & Size)	Redoximorphic Features (Depth, Color and Abundance)	Roots (Quantity & Size)	Soil Structure	Soil Moisture	Additional Notes	Horizon Photos
0-9	Loamy sand	Dark brown	No	No	Yes, few small	Granular (soil aggregates)	Slightly moist	Vegetated overlay

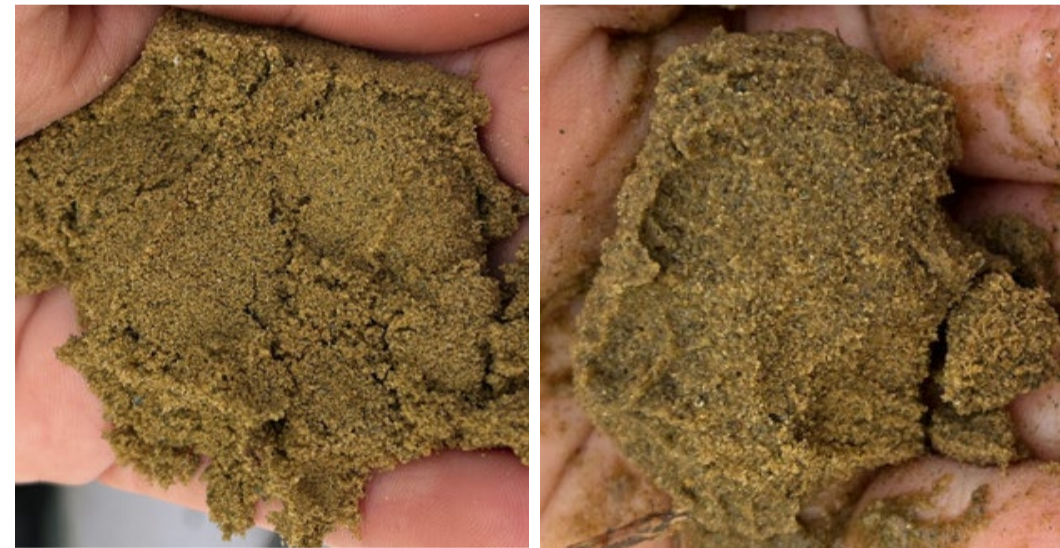
9-77	Sand	Orange-yellow-light brown	No	No	No	Single grain (loose mineral/rock grains)	Dry

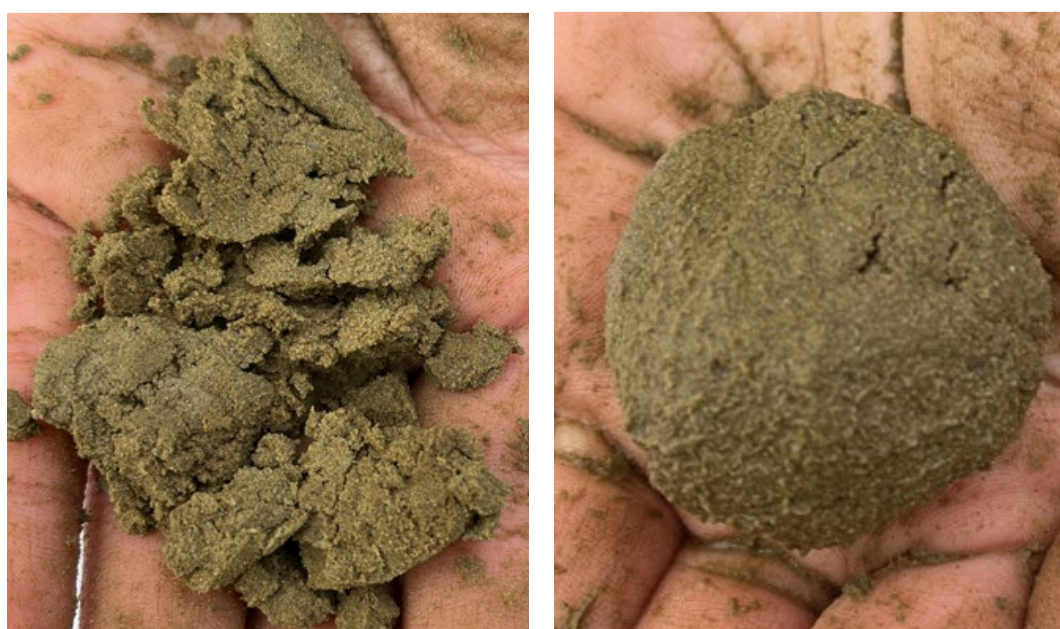
77-88	Silt loam	Light brown	No	No	No	Single grain (loose mineral/rock grains)	Moist to saturated	Potential confining layer, very fine sand, potential GW around 80"

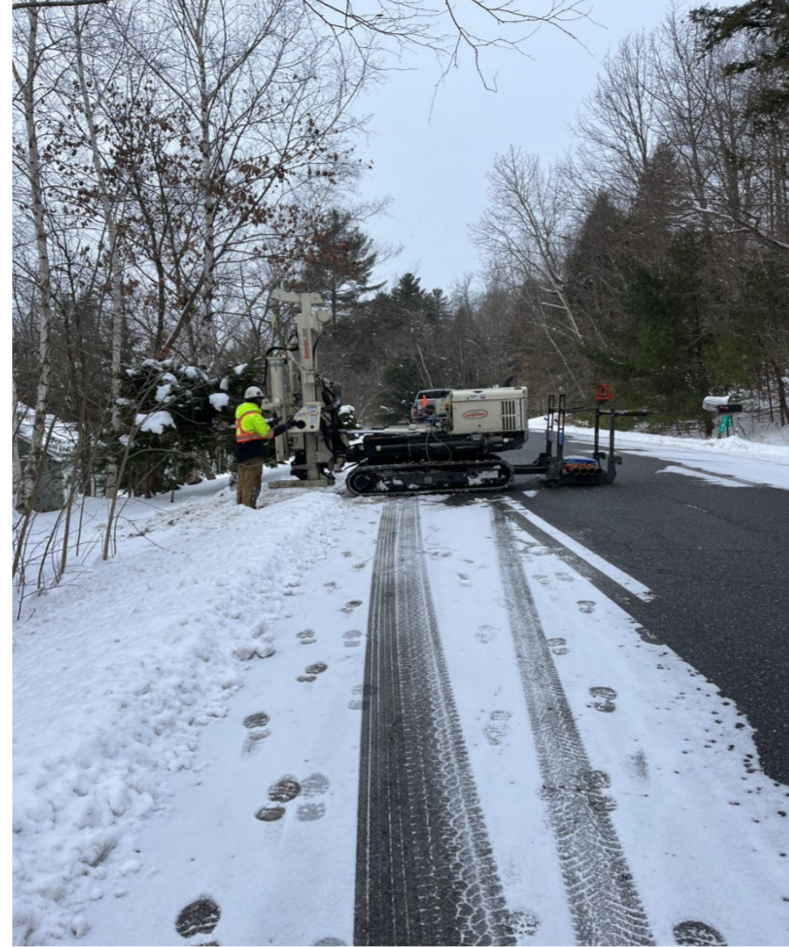
Site Photos

TP-4 was located outside 191 Joan Ave on the edge of the road. The boring was completed to a depth of 120", with seasonal high groundwater indicators noted at 42" in depth and the groundwater table at 78". The topsoil consisted of a loamy sand to 8" in depth, followed by a rocky sand layer with road base and geotextile mixed in from 8-24" in depth. The next layer consisted of silt loam from 24-86", with redoximorphic features identified at 42" and groundwater saturation at 78" in depth. There was another sand layer from 86-99" with redoximorphic features throughout and a clay layer from 99-120", both saturated. This area is mapped as Duane and Deerfield soils, designated HSG A/D. The A/D designation implies high groundwater conditions, which was confirmed by our field observations. The shallow seasonal high groundwater table precludes many in-ground practices, though a very shallow surface feature or an underdrained feature may have potential under these conditions.

Pit ID: TP-4	
Site Name: Southview	
Sampling Method: GeoProbe	Site Location: 191 Joan Ave, Richmond VT
Excavated Pit Depth: 120"	Excavation Date: 1/15/25
Depth to Water Table: 78"	Start Time: 1:41 PM
Depth to SHGW: 42"	Representative: AS, AShep
Overall Site Notes:

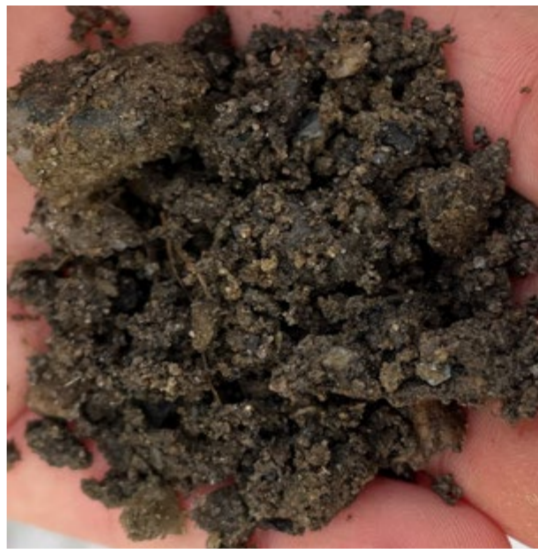
Depth (in)	Soil Texture (USDA)	Soil Color	Coarse Fragments (Quantity & Size)	Redoximorphic Features (Depth, Color and Abundance)	Roots (Quantity & Size)	Soil Structure	Soil Moisture	Additional Notes	Horizon Photos
0-8	Loamy sand	Dark brown	Yes, many coarse fragments, avg size 0.5"	No	Yes, few small, few medium	Granular (soil aggregates)	Dry	Vegetated overlay

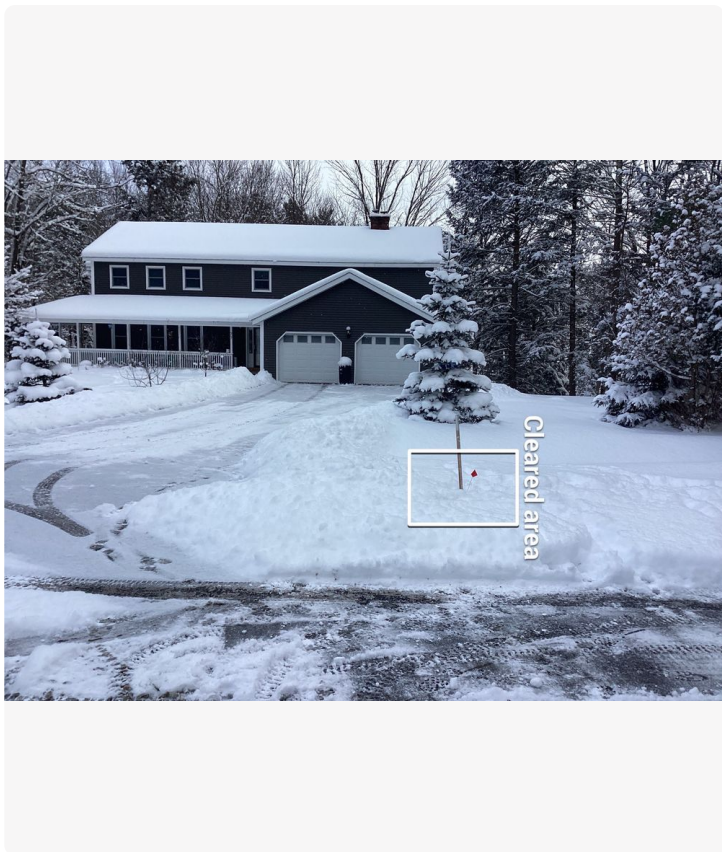
Point #1, Westall ext: Area clear (red flag is dig safe flag noting "no VEC, no GMP")

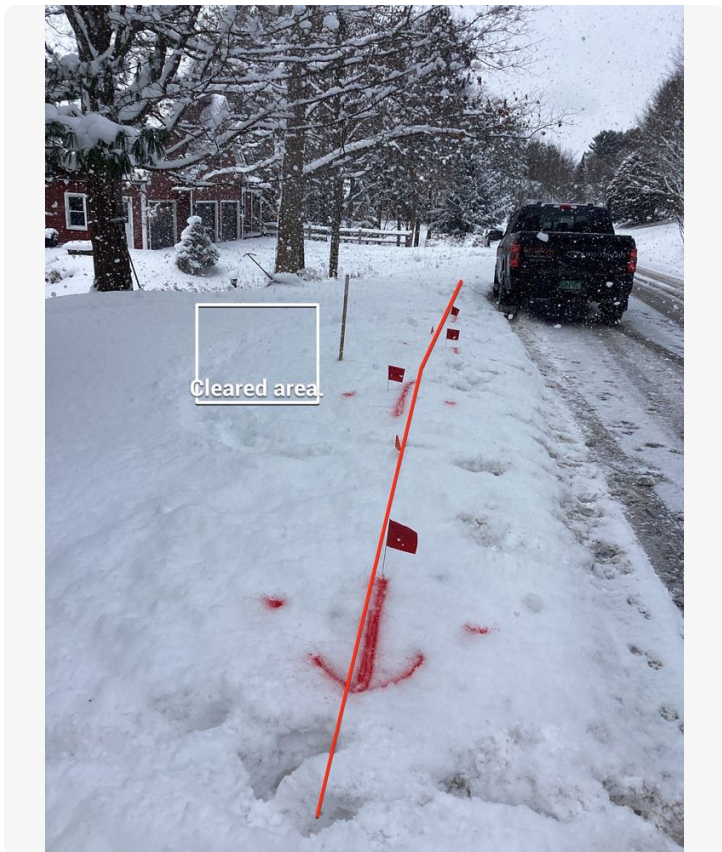
Point #2, Westall rd: Electrical line in close proximity to stake. Recommend moving stake back 3'-5'.

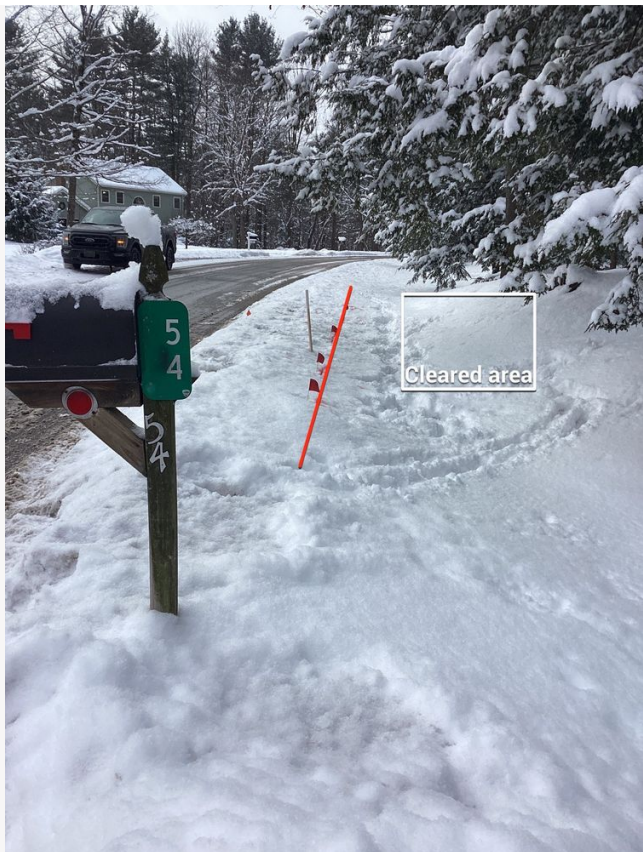
Point #3, Westall rd: electrical line crossing stake. Drill area should be moved back 3'-5'. Orange unmarked digsafe flag also present. Please refer to their report for findings.

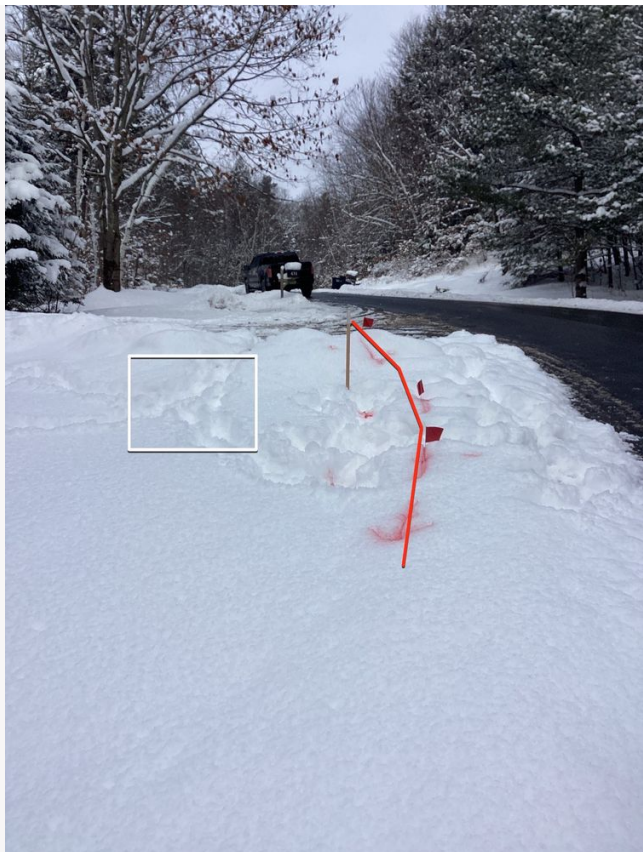
Point #6, Southview Dr: electrical line crossing stake. Drill area should be moved back 3'-5'. Orange unmarked digsafe flag also present. Please refer to their report for findings.

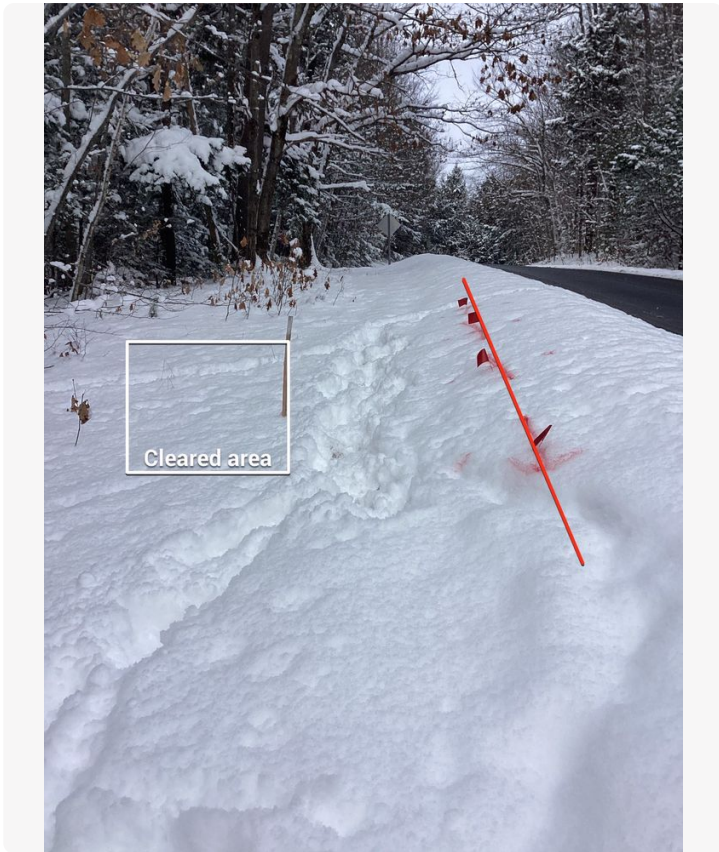
Point #5, southview dr: electrical line near stake. Recommend moving Drill area back 1'-2'.

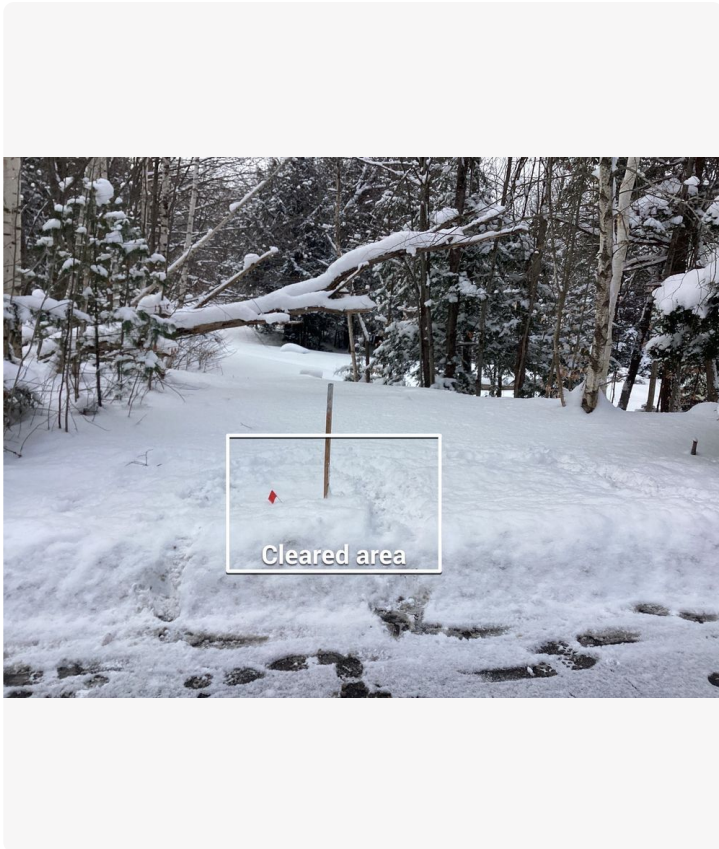
Point #4, Joanne ave: Area clear (red flag is dig safe flag noting "no VEC, no GMP")
