Richmond Street and Sidewalk Audit

Prepared by the Richmond Transportation Committee

4/28/2023

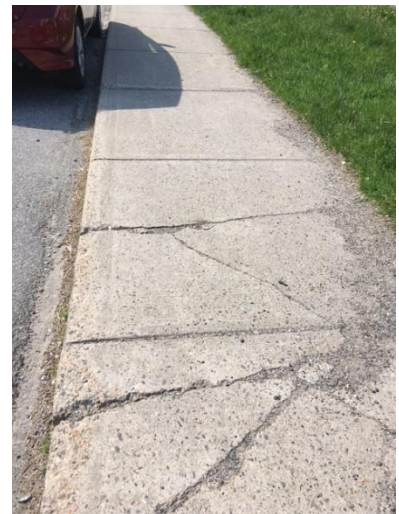
Deteriorated sidewalks and curbs

This section has curbed concrete sidewalks on both the north and south sides of Main St. The north side of the street has concrete curbs, and the south side of the street has granite curbs. The south side of the street has a green buffer strip between the roadway and the sidewalk. The north side of the street lacks a buffer between the roadway and the sidewalk. Volunteers observed the degradation of the sidewalks, and the lack of tactile pads for certain wider curb cuts.

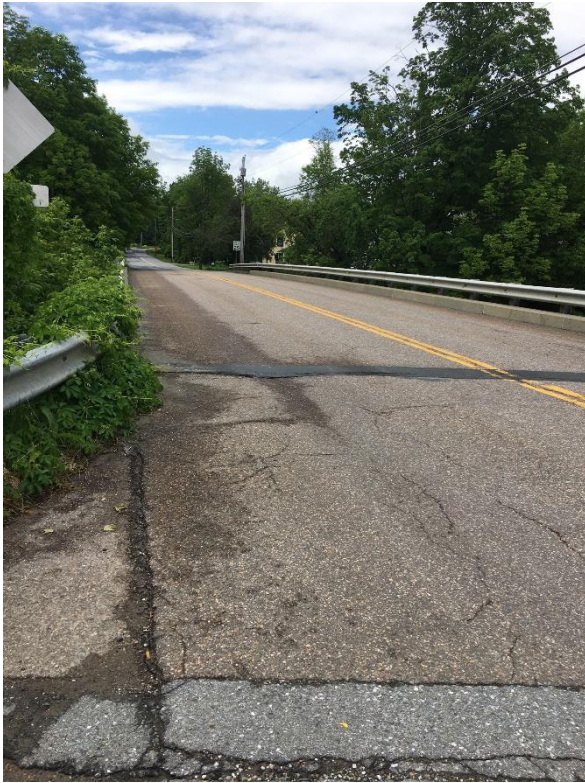
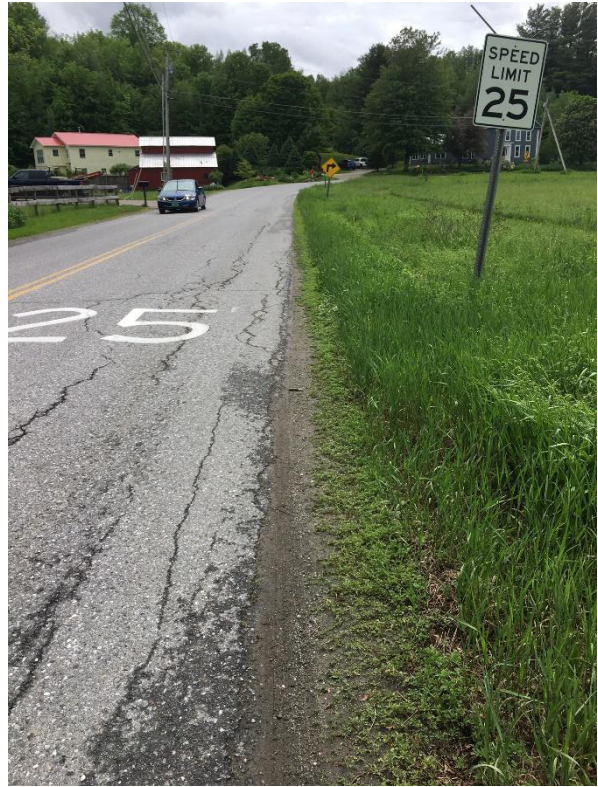
US Route 2 within the study area is a two-lane state road with narrow shoulders. The speed limit is 40 miles per hour. The road has neither bicycle nor pedestrian facilities. The roadway lacks signage or markings indicating to drivers of bicycle and pedestrian users. US Route 2 has no pedestrian crossings.

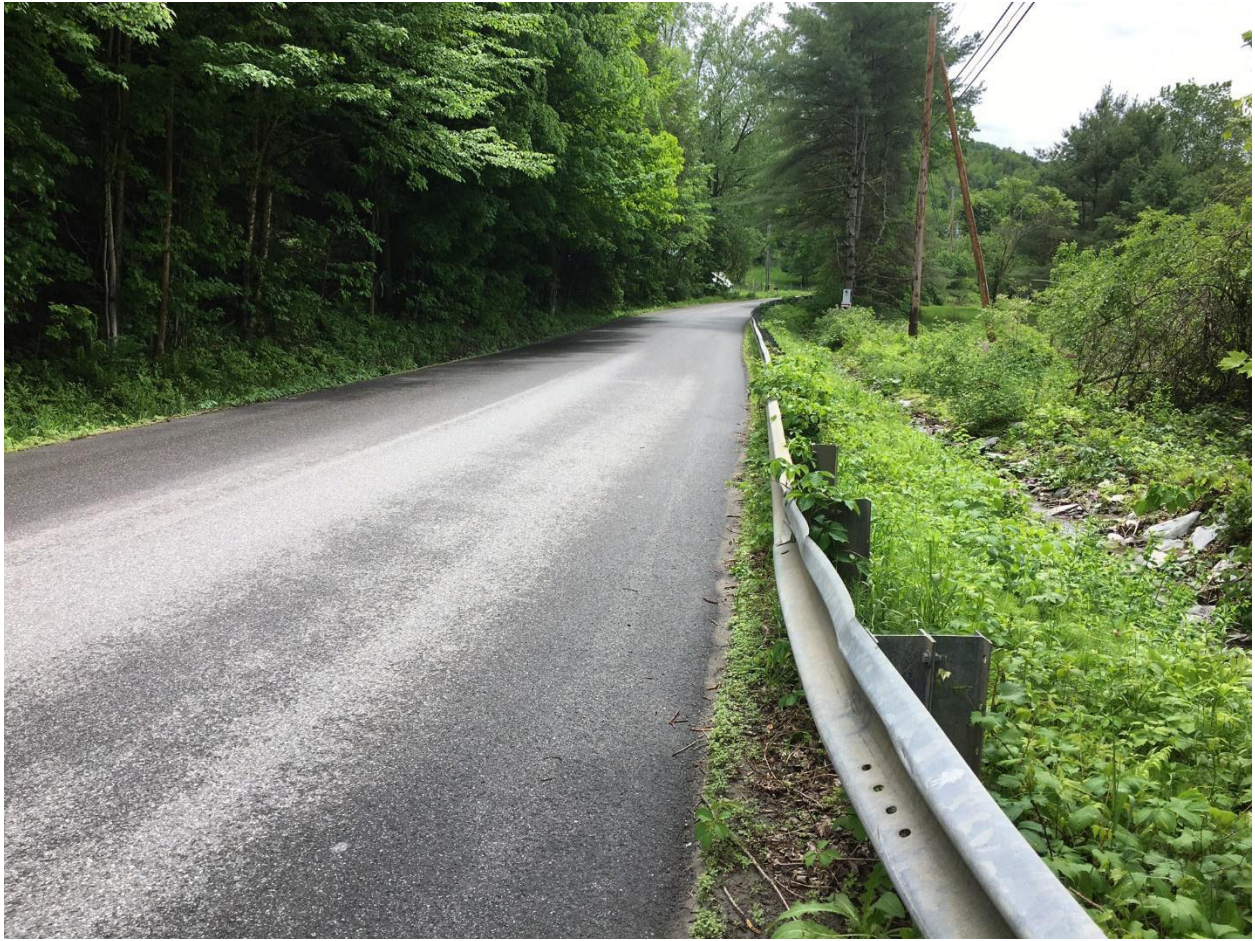
Cochran Road within this study area is a two-lane road with narrow to no shoulders and includes the bridges over the Winooski River and Huntington River. Only the centerlines are striped on this roadway. The roadway does not have bicycle or pedestrian facilities.

Cochran Road, and the roads stemming from it—Duxbury Road, Wes White Hill Road, and Dugway Road—are used by walkers, runners, bicyclists, and those looking to access the Huntington and Winooski Rivers.
