INFRASTRUCTURE MANAGEMENT

Report Date: 11/14/2023

Account Name: Richmond Water Resources
Asset Name: 750KG (2) Celled
Type of Tank: Finished Water
Dimensions: 47' x 47' x 25' deep.
Address: 281 Esplanade St, Richmond, VT 05477, USA
Latitude: 44.40382
Longitude: -73.000713
Services: Clean (Sediment Removal)|Inspection|Mixer Install
Tank Identification Plate:

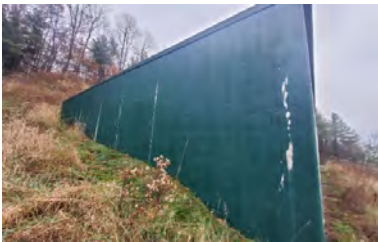
Overall photo of North quadrant

NORTH WALL	
Are there any signs of cracks?	Yes
Percent (%) of cracks in this quadrant	5% -10%
Do any of these cracks have efflorescence?	Yes
Percent (%) of cracks having efflorescence	Greater than 20%
Do any of these cracks have depth?	No
Do any of these cracks have width?	No
Are these cracks sealed?	No
Were any areas of voiding found?	No
Were any areas of spall evident?	No

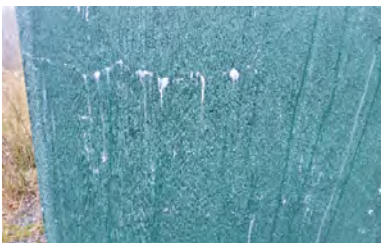
Photos of cracks

Are there any signs of cracks?	Yes
Percent (%) of cracks in this quadrant	5% -10%
Do any of these cracks have efflorescence?	Yes
Percent (%) of cracks having efflorescence	Greater than 20%
Do any of these cracks have depth?	No
Do any of these cracks have width?	No
Are these cracks sealed?	No
Any areas of voiding found?	No
Were any areas of spall evident?	No

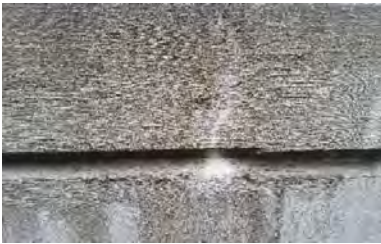
Photos of cracks

EAST WALL	
Are there any signs of cracks?	Yes
Percent (%) of cracks in this quadrant	5% -10%
Do any of these cracks have efflorescence?	Yes
Percent (%) of cracks having efflorescence	Greater than 20%
Do any of these cracks have depth?	No
Do any of these cracks have width?	No
Are these cracks sealed?	No
Any areas of voiding found?	No
Were any areas of spall evident?	No

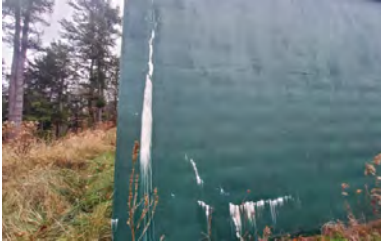
Photos of cracks

WEST WALL	
Are there any signs of cracks?	Yes
Percent (%) of cracks in this quadrant	5% -10%
Do any of these cracks have efflorescence?	Yes
Percent (%) of cracks having efflorescence	Greater than 20%
Do any of these cracks have depth?	No
Do any of these cracks have width?	No
Are these cracks sealed?	No
Any areas of voiding found?	No
Were any areas of spall evident?	No

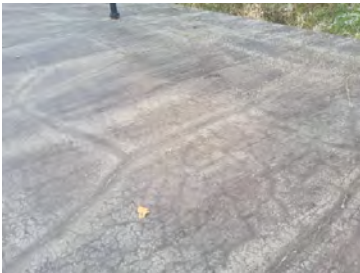
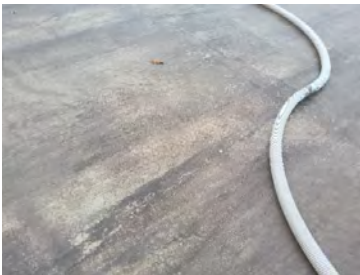
East Roof Quadrant Aesthetics Photos

EAST ROOF QUADRANT AESTHETICS	
Aesthetic Deficiencies	Mildew
Condition of Protective Coating	Decline/Thinning

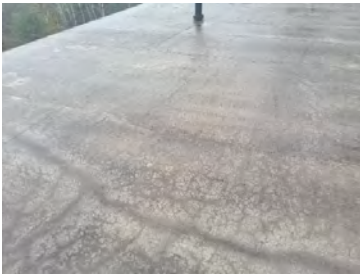
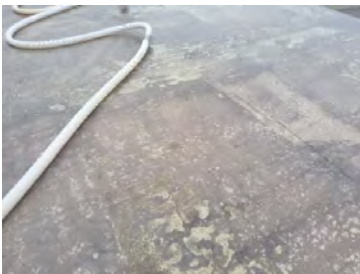
West Roof Quadrant Aesthetics Photos

WEST ROOF QUADRANT AESTHETICS	
Aesthetic Deficiencies	Mildew
Condition of Protective Coating	Decline/Thinning

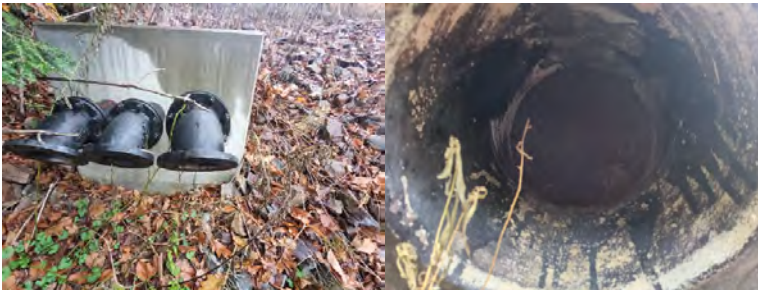
Overflow #1 Photo

OVERFLOW #1	
Location #1	North
Location #2	Wall
Is this overflow free of obstructions?	Yes
Is there a screen present?	Yes
What size mesh is this screen?	24
Is this screen secure?	Yes
Overflow # 1 Does this screen have any deficiencies?	No
Does the overflow have a flapper gate or a duckbill valve?	No
Does this overflow terminate from the roof?	No
Where does this overflow terminate?	100' north above rip rap
How many inches above the ground does it terminate?	24
What is the diameter of this overflow?	8
Does this overflow discharge into a sewer or storm drain?	Yes

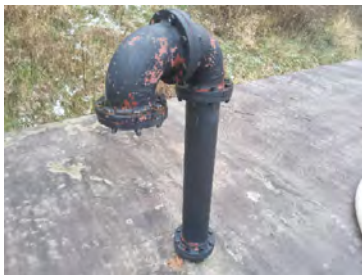
Vent #2 Photos

VENT #2	
Location #1	Northeast
Location #2	Roof
Is this vent coated?	Yes
What is the condition of the coating?	Decline/Thinning
Is this vent downturned?	Yes
Is this vent at least 24" or 3 pipe diameters above the roof?	Yes
Does this vent have a screen?	Yes
What size mesh screen does it have?	24
Is this screen secure?	Yes
Does this screen have any deficiencies?	No
Is the vent a vacuum/pressure release pallet vent?	No

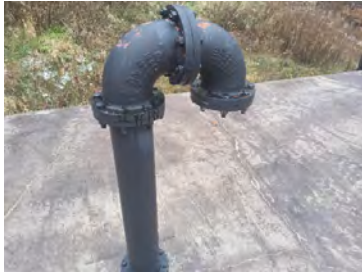
Vent #3 Photos

VENT #3	
Location #1	Southeast
Location #2	Roof
Is this vent coated?	Yes
What is the condition of the coating?	Decline/Thinning
Is this vent downturned?	Yes
Is this vent at least 24" or 3 pipe diameters above the roof?	Yes
Does this vent have a screen?	Yes
What size mesh screen does it have?	24
Is this screen secure?	Yes
Does this screen have any deficiencies?	No
Is the vent a vacuum/pressure release pallet vent?	No

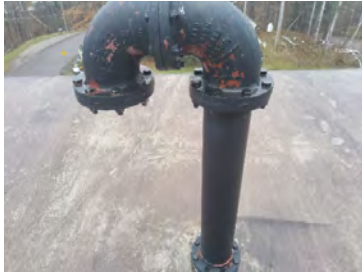
Vent #4 Photos

VENT #4	
Location #1	Southwest
Location #2	Roof
Is this vent coated?	Yes
What is the condition of the coating?	Decline/Thinning
Is this vent downturned?	Yes
Is this vent at least 24" or 3 pipe diameters above the roof?	Yes
Does this vent have a screen?	Yes
What size mesh screen does it have?	24
Is this screen secure?	Yes
Does this screen have any deficiencies?	No
Is the vent a vacuum/pressure release pallet vent?	No

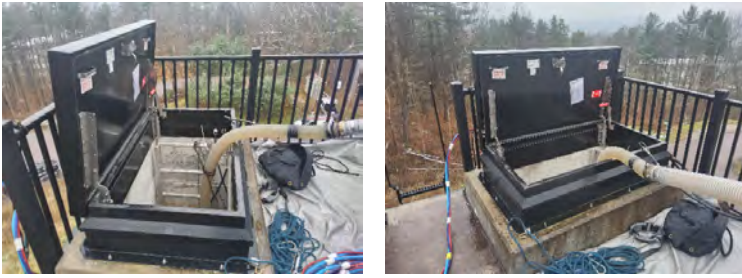
Hatch Photos

HATCH #1	
Location #1	Southwest
Location #2	Roof
Shape	Rectangle
Length (in inches)	54
Width (in inches)	30
Is this hatch raised at least 4" above the roof?	Yes
What is the height this hatch is raised above the roof?	13
Does this hatch have an overlapping water tight lid?	Yes
Does this lid measure 2" in overlap?	No
What is the measurement of the overlap?	1.5
Does this lid have a gasket?	Yes
What is the condition of this gasket?	Good
Was this hatch opened during inspection?	Yes
Did this hatch function properly?	Yes
Is this hatch secured with a lock?	Yes
Is this hatch coated?	Yes
Condition of coating on exterior	Good

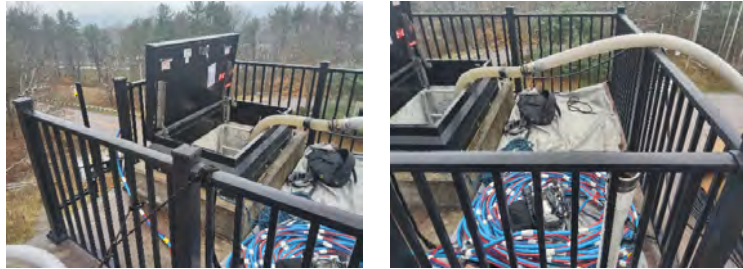
Safety Railing Photos

Does this structure have safety railings?	Yes
What is the material of the safety railings?	Aluminum
Is this safety railing coated?	Yes
Condition of coating	Good
Is this safety railing at least 42" to 43" in height?	Yes
What is the diameter of the tubing? (In Inches)	N/A
Does it span the circumference of the structure?	No
What is the approximate length of this railing? (In Inches)	424
Where is this safety railing located?	Around the hatch
Does this railing have a mid rail?	No
Does this railing have a toe plate?	No
Is this safety railing secure?	Yes
What is the overall condition of this safety railing?	Good

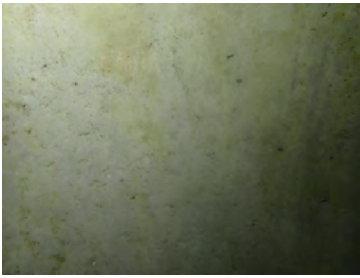
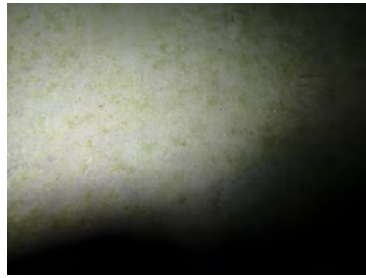
North Wall Aesthetics Photos

INTERIOR AESTHETICS NORTH WALL	
Is there Biofilm/Staining in this quadrant?	Yes
Severity of biofilm/staining?	Mild
Is this quadrant coated?	No

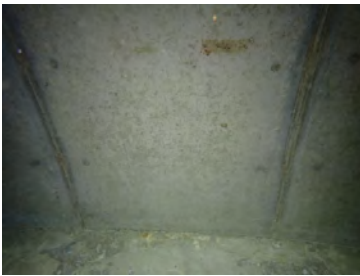
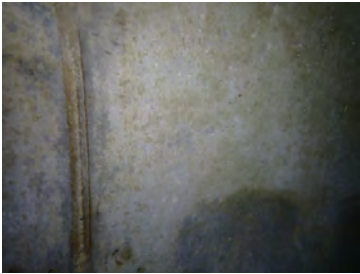
South Wall Aesthetics Photos

Is there Biofilm/Staining in this quadrant?	Yes
Severity of biofilm/staining?	Mild
Is this quadrant coated?	No

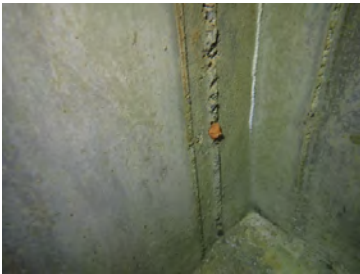
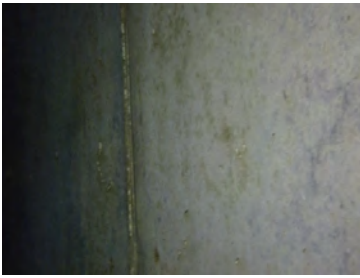
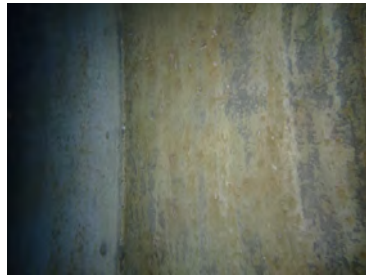
East Wall Aesthetics Photos

Is there Biofilm/Staining in this quadrant?	Yes
Severity of biofilm/staining?	Mild
Is this quadrant coated?	No

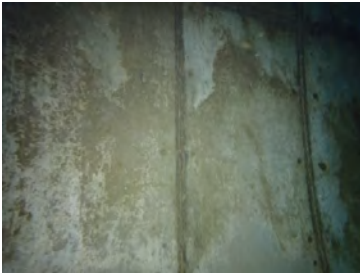
West Wall Aesthetics Photos

Is there Biofilm/Staining in this quadrant?	Yes
Severity of biofilm/staining?	Mild
Is this quadrant coated?	No

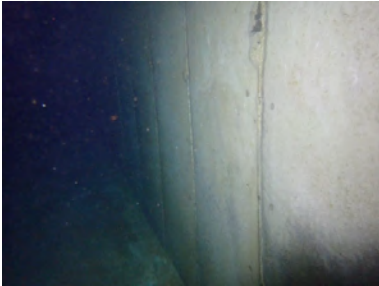
Overall Photo of Interior North Wall Quadrant

Are there any signs of cracks?	Yes
Percent (%) of cracks in this quadrant	5% -10%
Do any of these cracks have efflorescence?	Yes
Percent (%) of cracks having efflorescence:	Less than 5%
Do any of these cracks have depth?	No
Do any of these cracks have width?	No
Are these cracks sealed?	No
Were any areas of spall evident?	No
Additional Notes	5% corrosion nodules

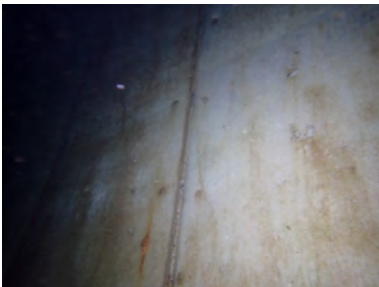
Overall Photo of Interior South Wall Quadrant

Are there any signs of cracks?	Yes
Percent (%) of cracks in this quadrant	Less than 5%
Do any of these cracks have efflorescence?	Yes
Percent (%) of cracks having efflorescence:	Greater than 20%
Do any of these cracks have depth?	No
Do any of these cracks have width?	No
Are these cracks sealed?	No
Were any areas of spall evident?	No
Additional Notes	5% corrosion modules

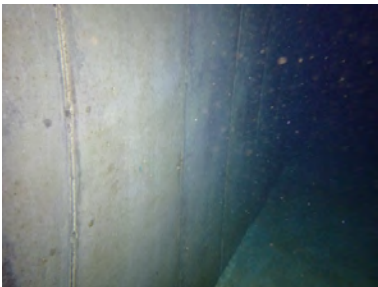
Overall Photos of Interior East Wall Quadrant

Are there any signs of cracks?	Yes
Percent (%) of cracks in this quadrant	5% -10%
Do any of these cracks have efflorescence?	Yes
Percent (%) of cracks having efflorescence:	Greater than 20%
Do any of these cracks have depth?	No
Do any of these cracks have width?	No
Are these cracks sealed?	No
Were any areas of spall evident?	No
Additional Notes	5% corrosion nodules

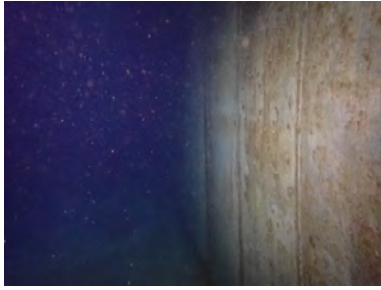
Overall Photos of Interior West Wall Quadrants

Are there any signs of cracks?	Yes
Percent (%) of cracks in this quadrant	Less than 5%
Do any of these cracks have efflorescence?	Yes
Percent (%) of cracks having efflorescence:	Greater than 20%
Do any of these cracks have depth?	No
Do any of these cracks have width?	No
Are these cracks sealed?	No
Were any areas of spall evident?	No
Additional Notes	5% corrosion nodules

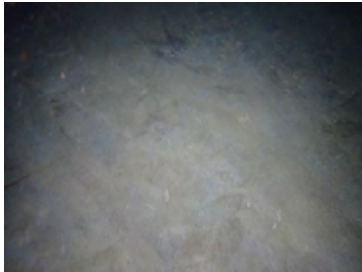
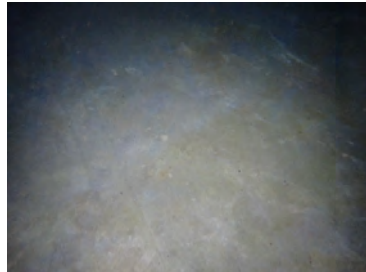
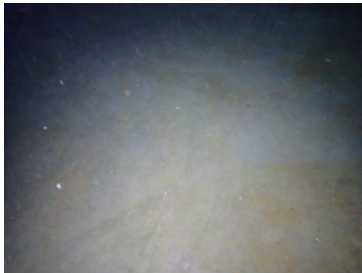
North Floor Aesthetics Photos

INTERIOR AESTHETICS NORTH FLOOR	
Is there Biofilm/Staining in this quadrant?	Yes
Severity of biofilm/staining?	Mild
Is this quadrant coated?	No

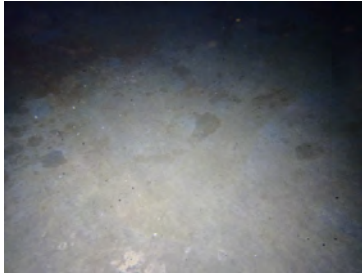
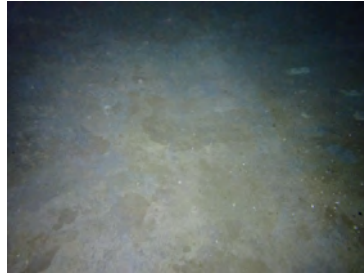
West Floor Aesthetic Photos

Is there Biofilm/Staining in this quadrant?	Yes
Severity of biofilm/staining?	Mild
Is this quadrant coated?	No

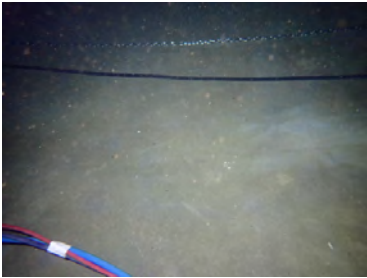
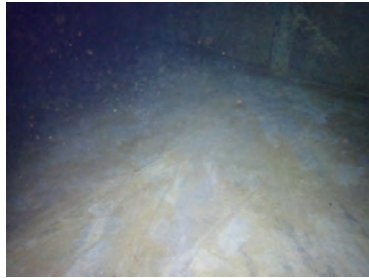
After Sediment Removal

SEDIMENT REMOVAL	
How much sediment was found on the bottom of this structure? (in inches)	0.03125
Sediment appears to be:	Brown sediment and minor corrosion from ladder and overflow
Was all sediment removed?	Yes

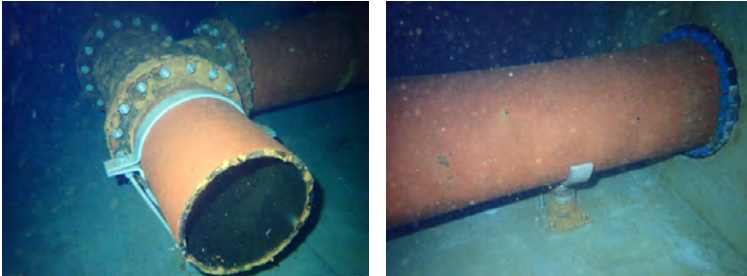
Pipe #1 Photos

Where does this pipe penetrate the structure?	Wall
Does this pipe penetrate from a sump?	No
Does this pipe terminate within a sump?	No
What is the diameter of this pipe? (in inches)	16
What is the material of this pipe?	Steel
Is this pipe obstructed?	No
Is there anything on the end of this pipe?	Nothing
Was there flow at the time of inspection?	No
Is this pipe coated?	Yes
Condition of coating	Decline/Thinning
Is this pipe supported?	Yes
How many places is this pipe supported?	7
What is the condition of the support(s)?	Fair condition

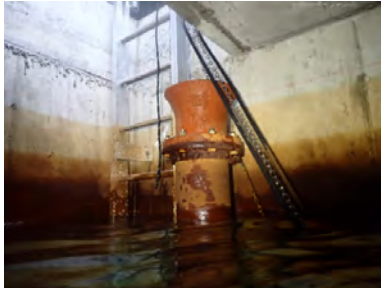
Overflow #1 Photo

Location #1	West
Location #2	Wall
Is this overflow free of obstructions?	Yes
What is this overflow penetrating?	Floor
Where does this overflow terminate?	Approximately 8" from overhead
Is this overflow coated?	Yes
Condition of coating	Decline/Thinning
Is this overflow supported?	Yes
What is the condition of the supports?	Fair

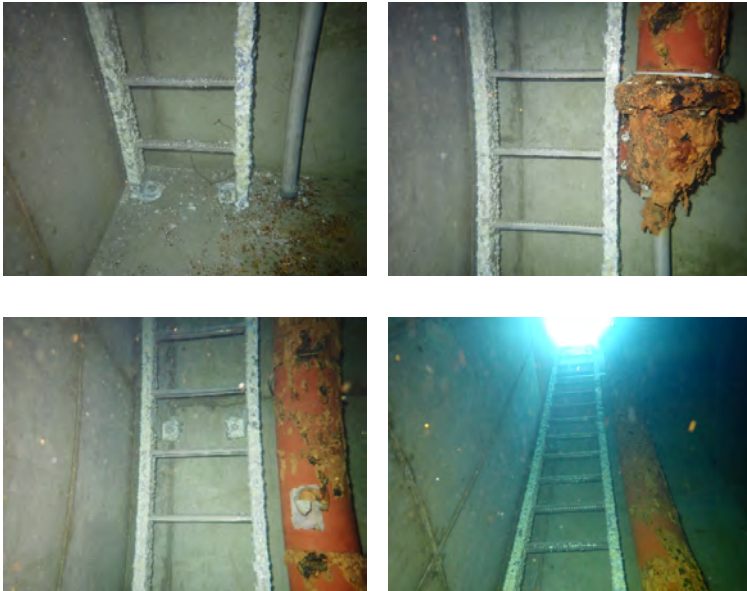
Interior Ladder Photos

Does this ladder have a fall prevention device?	No
Does this ladder have a safety cage?	No

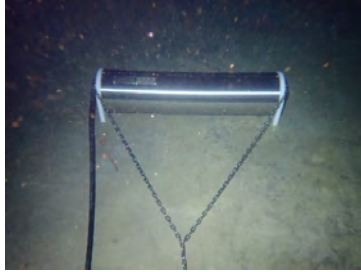
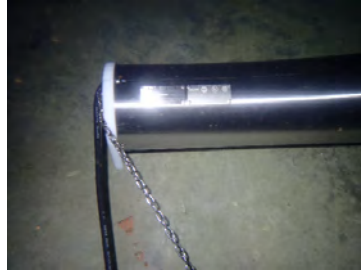
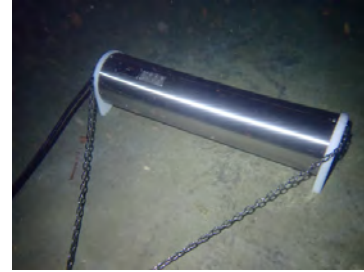
Interior Mixer Photos

INTERIOR MIXER	
Does this structure have a mixer installed?	Yes
What kind of mixer is installed?	Active
What is the brand of the mixer?	Gridbee
Type of mount?	Floor Mount
Is the mixer in operation at time of this inspection?	Yes
Is there any obstructions/failures?	No
Interior Mixer - Additional Notes	This is the new mixer we installed, there is another gridbee on the west side of the tank floor.
